Check It Out Property Inspections

CONFIDENTIAL INSPECTION REPORT

1717 Coronado Avenue, San Diego, CA 92154

8/31/2011 9:00 am to 4:15 pm

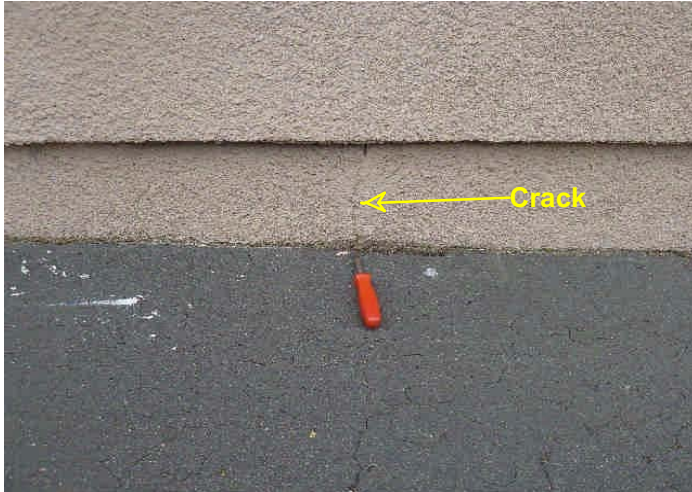
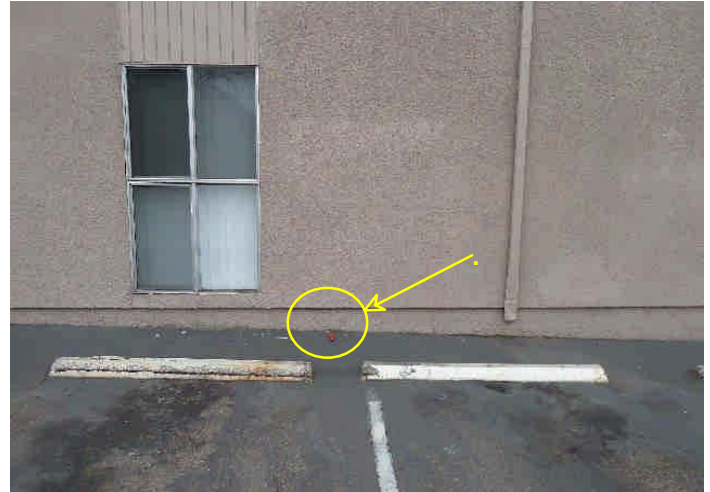
- There was one crack noted at the rear/east side stem wall. The crack was less than 1/16" wide and did not appear to present separation or offsets. Cracks in a slab stem wall, while not common, do not necessarily have serious structural significance, however we are not qualified to determine this and you may wish to have the slab foundation evaluated by a qualified professional engineer.

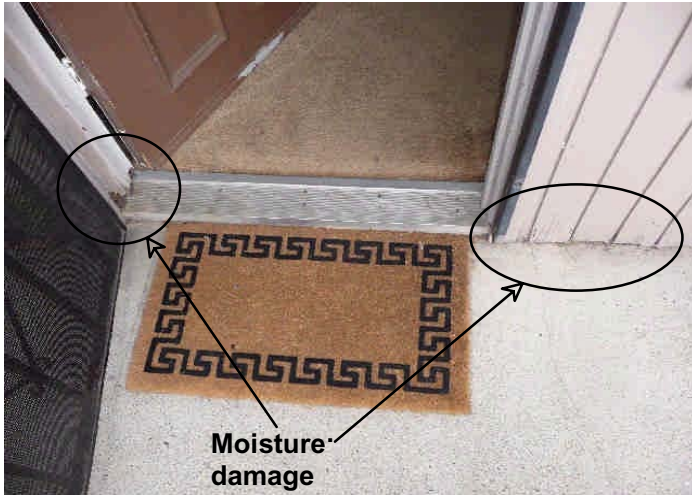
- ❖ Moisture damage was noted at the walls of the residence at second floor at entry door of unit 10. Repair is needed.

Moisture damage - Continued

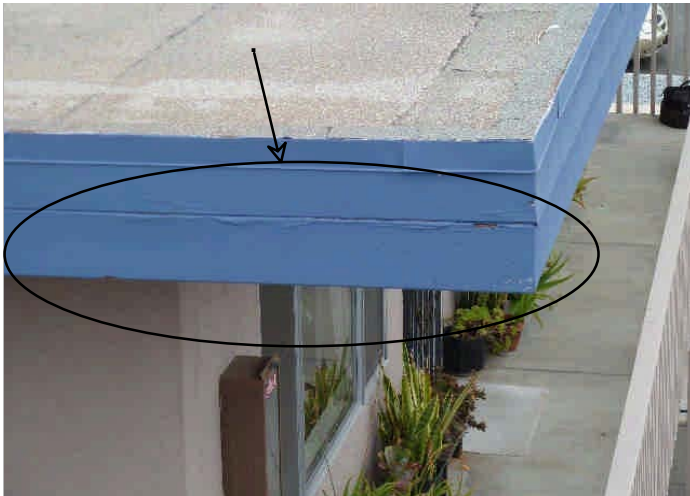
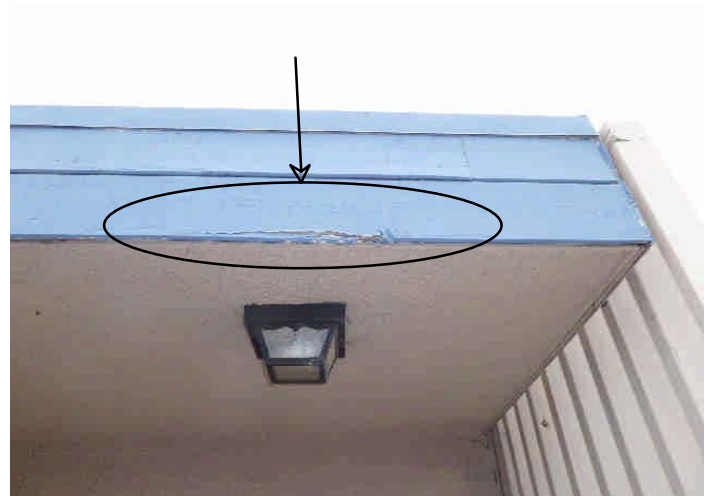
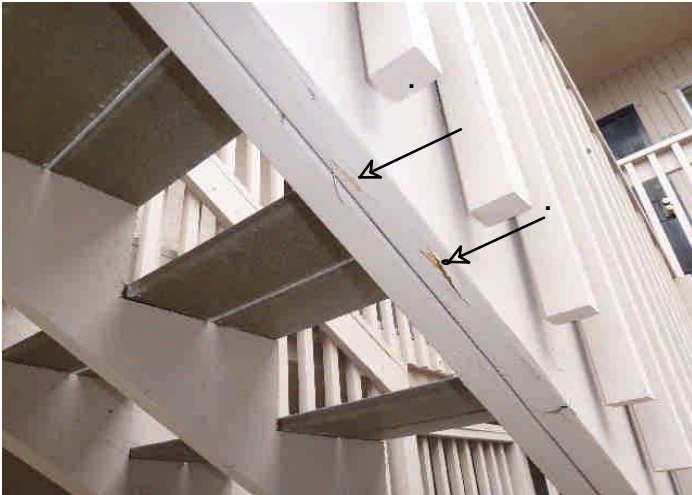
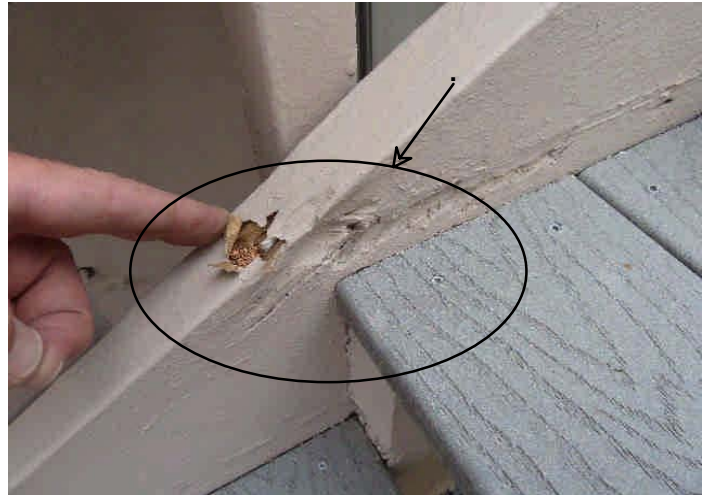
- ❖ There is moisture damage and deterioration to the wood trim at eaves/fascia board. Repairs are needed. A qualified licensed contractor should evaluate the wood and trim features and replace any damaged wood. A qualified termite inspector should evaluate the wood features of the building and take action as needed.

Damage eave-fascia-stair stringers and handrails Repairs needed Termite inspection advised - Continued

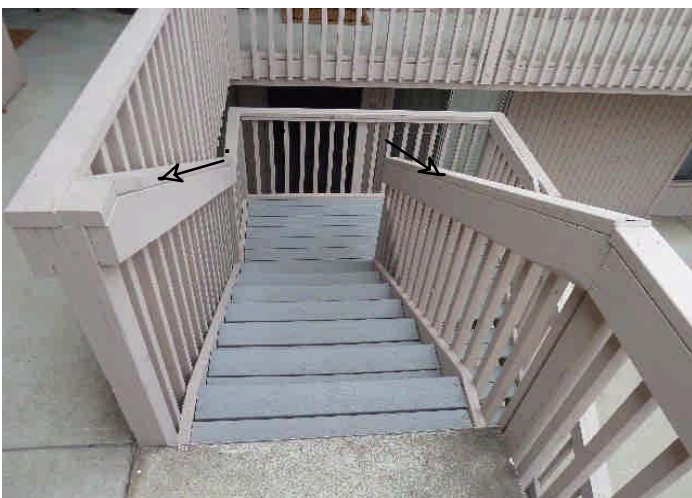
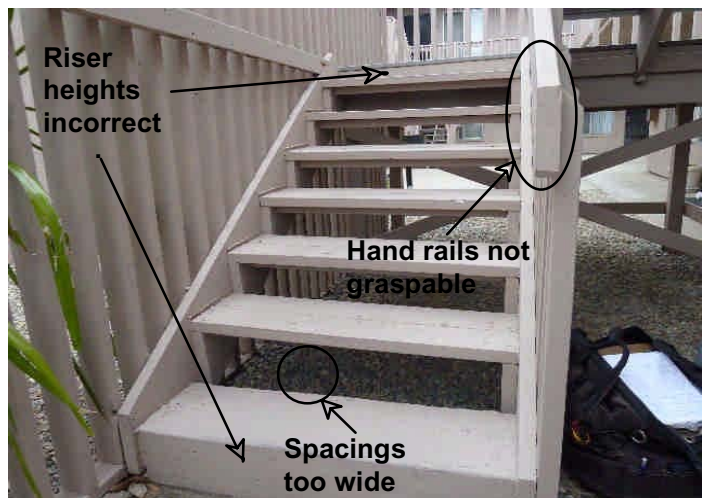
- ❖ The stair hand rails are not graspable types and we advise upgrading the handrails for safety. Modern safety standards require stair handrails to be grippable and have a circular cross section of between 1 and 1/4" - 2 and 5/8" so that a person can grab the hand rail in the event they need to steady or catch themselves while ascending/descending stairs.

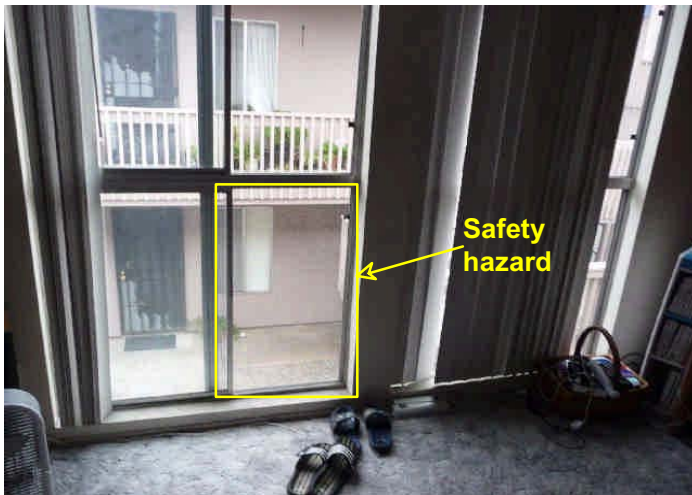
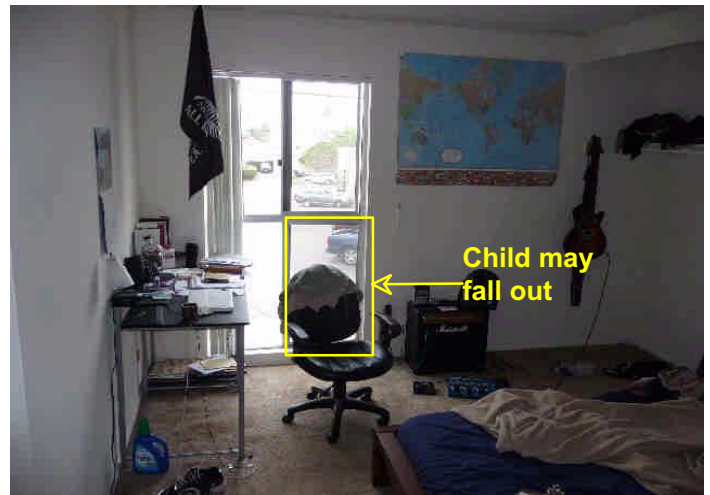
- ❖ The second floor openable windows at the eight upstairs residences and the laundry room have sill heights of less than 24" from the finished floor and an unsupervised child may fall through and out. Modern building standards prohibit windows above grade level location open no more than 4" for child safety. The windows may have conformed to past building standards, however safety standards have changed and the windows' sill heights will obviously be a safety hazard. Consult a qualified licensed contractor for a solution which meets the needs for safe egress from bedrooms while restricting openings.

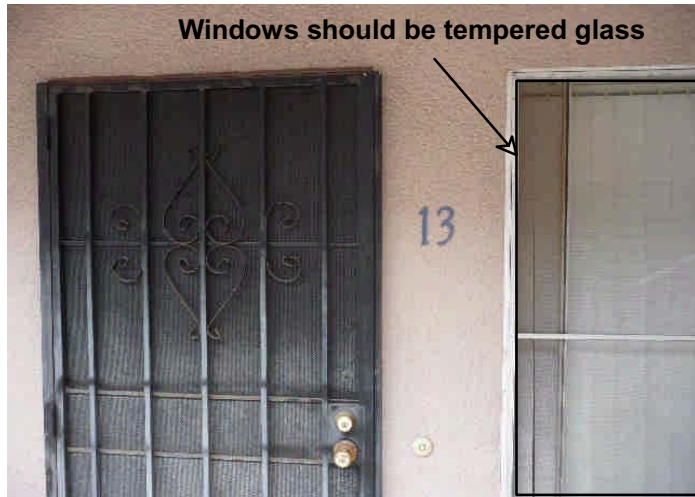
- ❖ The window adjacent to the entry doors of many units are potential safety hazards as the glazing in the windows did not appear to be tempered glass. Windows within 24" of the strike/closing side of a door are to be tempered glass for safety as a locked out tenant or burglar may attempt to break the window to gain access. Replacement with tempered glass is advised. Consult a licensed glazing contractor for further evaluation.

Not tempered Within 24 inches of door - *Continued*

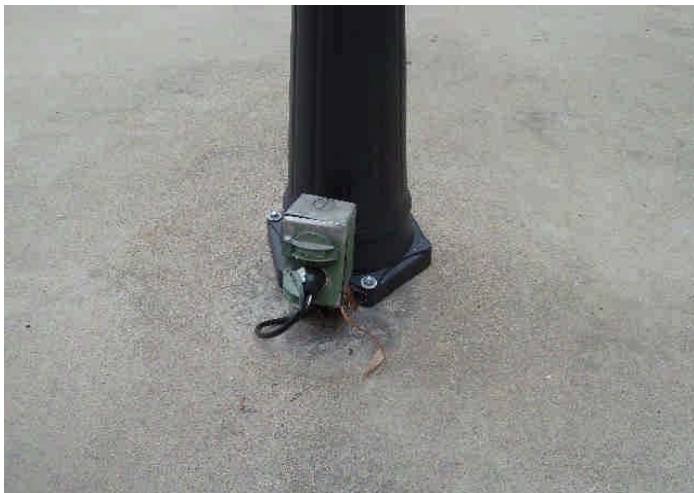
- ❖ The exterior outlets did not appear to be GFCI (ground fault circuit interrupter) protected. This important safety feature is required and upgrading to GFCI protection is needed.

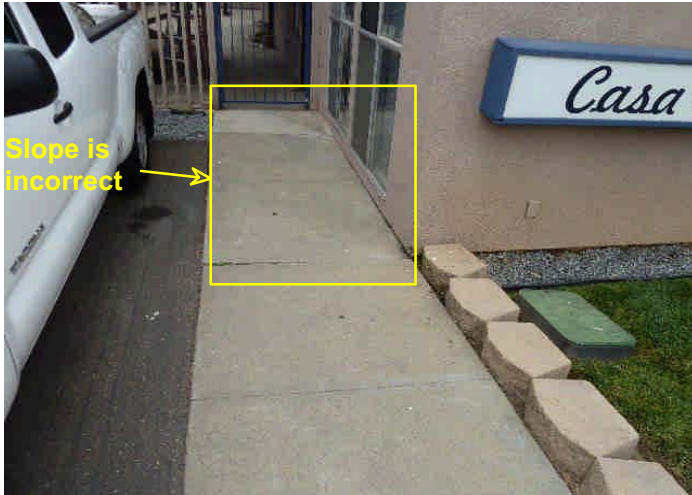
- ❖ There are areas at the front walkway where water will be directed toward the structure instead of away from it as required. The possibility of differential settling of foundation and hard surfaces, and moisture intrusion to walls and floors exists. Concrete/hardscape and soils should slope away from the structure at a rate of 6" in 10' (or 5% where area is restricted), to prevent moisture damage and differential settling. A qualified contractor should correct as needed.

Slope is neutral or towards house - *Continued*

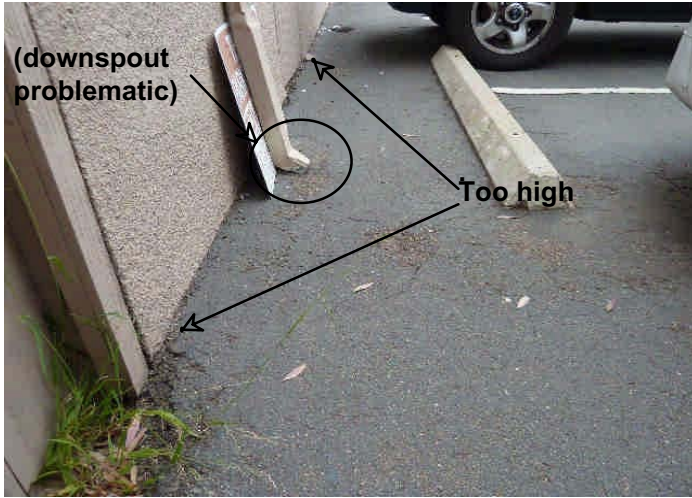
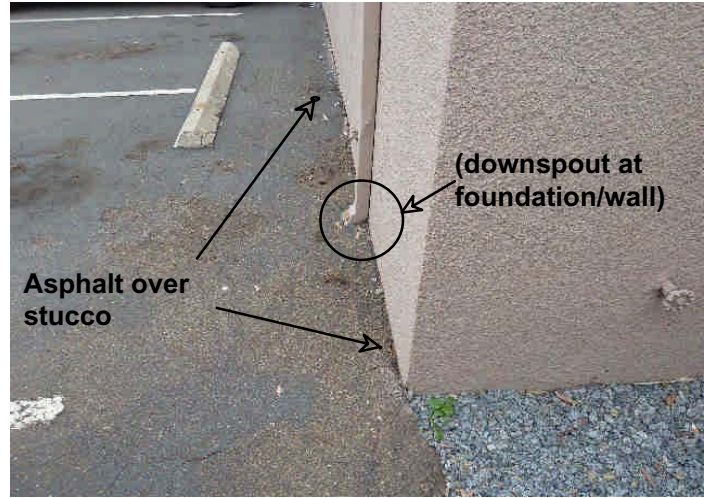
- ❖ The exterior grade is too high adjacent to the residence at the front left/west side asphalt driveway hardscape location and moisture intrusion will remain a possibility. Hard surfaces should originate 2" below the bottom edge of the stucco's weep screed (4" below the elevation of interior floors). The slope of exterior surfaces should be consistently away from the residence. Proper exterior surface elevations and slope are vital in keeping moisture away from the footings and house's siding. We advise further evaluation and correction from a qualified grading and drainage contractor.

Hardscape high Correction advised - Continued

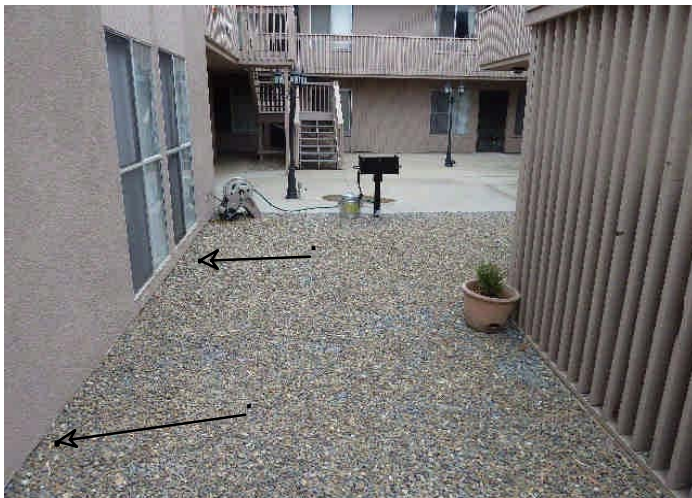
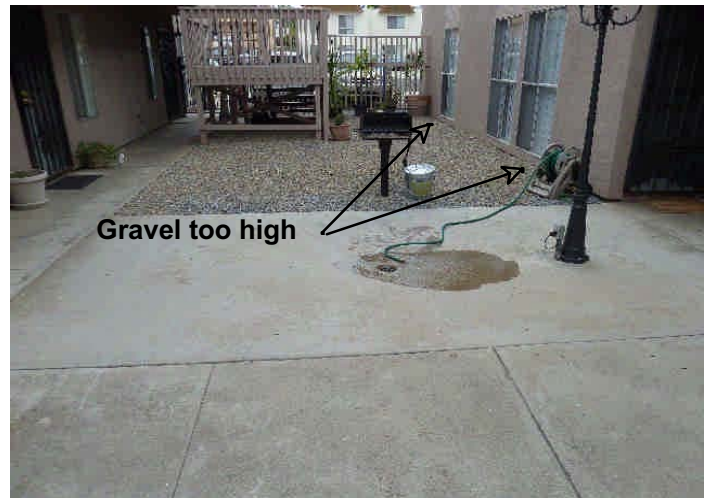
- The interior walls may be subject to moisture intrusion in some places adjacent to the gravel-finished grade areas and the surface elevation and grade should be considered for modification. The grade is set too high: Soil, ground cover and gravel should originate 4" below the bottom edge of any siding or stucco weep screed (6" below level of interior slab). The siding will be subject to some moisture and over time the interior walls may suffer damage. Although re-grading would be a significant undertaking, it is one that should be considered for the well being of the areas of living space.

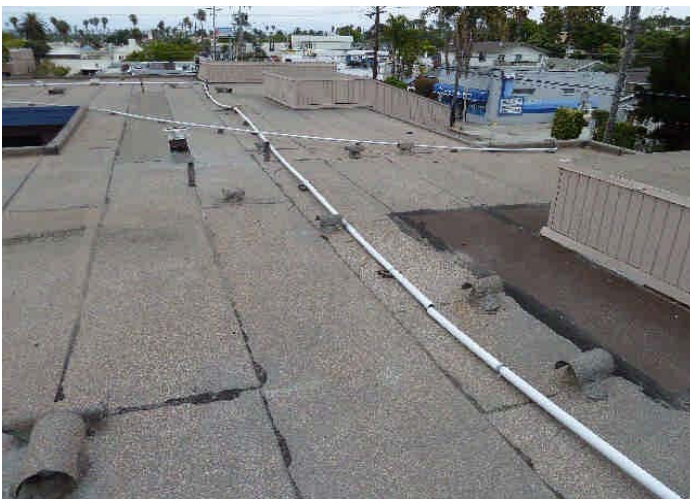
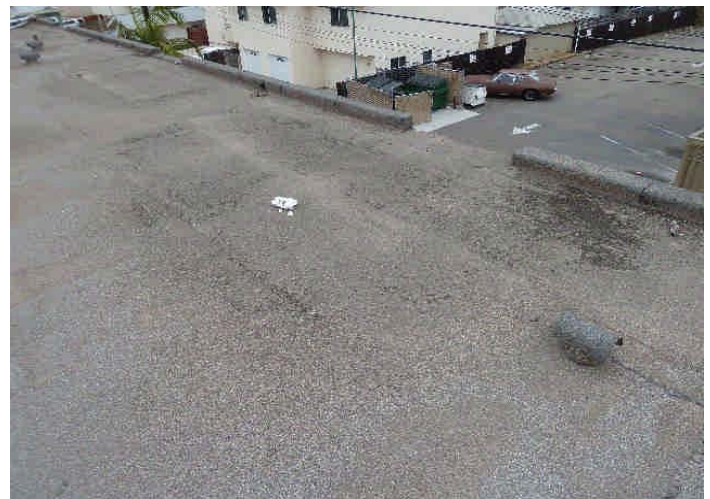
- ★ The roof is a low-sloped, modified bitumen type with torched down seams. Low-sloped roofs are designed to be waterproof, not just water resistant, and to last approximately 15 - 20 years. Though sometimes referred to as "flat roofs" they should not be flat, rather they should slope towards drains or roof edges at eaves. Drains should include primary surface drains at the low points and secondary drains at the perimeter or surrounding parapet walls. Water ponds on many of these roofs, and will only be dispersed by evaporation. For this and related reasons, low-sloped roofs have always been problematic and must have regular maintenance service. Modified bitumen membrane roofs are comprised of asphalt or acrylic impregnated and mineral-finished rolled roofing material, the seams of which are heat fused with a torch or adhered at seams with adhesive method stipulated by the manufacturer to form a moisture proof surface. The materials expand and contract in the daily temperature extremes and eventually buckle, split, separate, and finally deteriorate. When this happens, the roof is susceptible to leaks. Though gradual decomposition of the roofing materials is inevitable, most leaks result from poor maintenance. A low-sloped roof should be cleaned and inspected seasonally and serviced as needed.

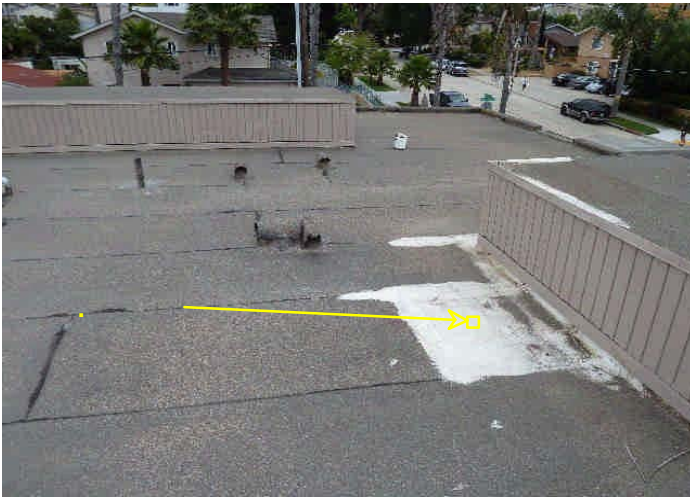
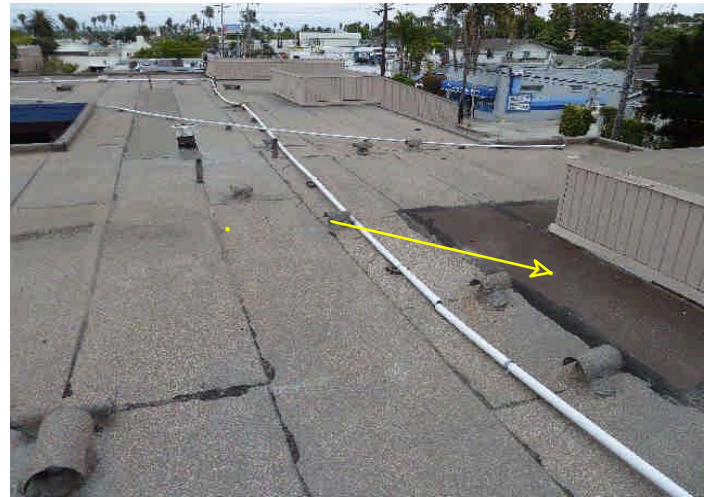
- There are moisture stains within the residences that appeared to be dry at the time of the inspection. Repairs or patching was noted at the roof in a few places. Active leakage can be difficult to trace and confirm when it is not raining however. Ask the sellers about the stains, repairs and any history of leaks or material defects. Obtain written documentation of past roof service and repairs and request a transferable warranty if possible. In lieu of sufficient documentation, have the roof evaluated by your own expert/licensed roofing contractor before the conclusion of your inspection period and close of escrow.

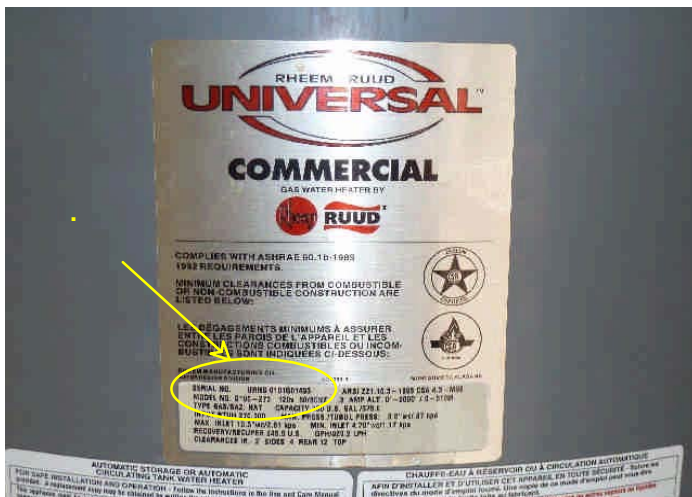
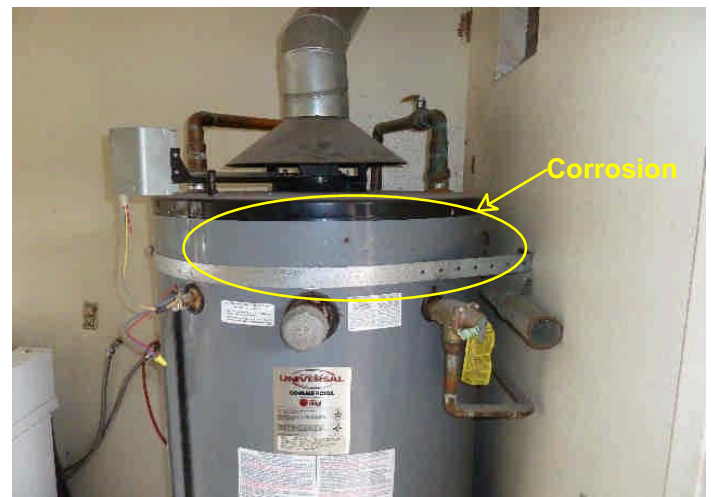
- ❖ The water heater was estimated to be approximately 18 yrs old or manufactured in 1993, as determined from the serial # on the label. There are rust particulates within the combustion chamber, which indicates deterioration to tank. There is corrosion to the exterior of tank. The water heater appears to be beyond its service life and we advise replacement at this time. You may wish to seek a second opinion from a qualified licensed plumbing contractor.

- The water heater was functioning at the time of the inspection, but is likely beyond its warranty period (see above). While no leaking was noted, it is recommended to take appropriate steps to prepare for its eventual failure.

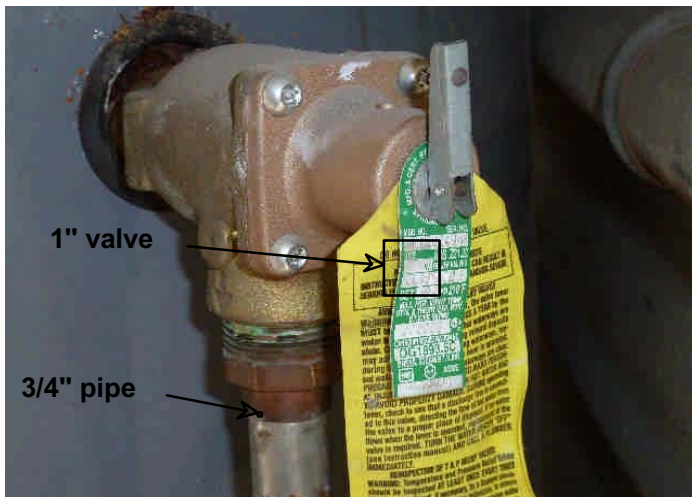
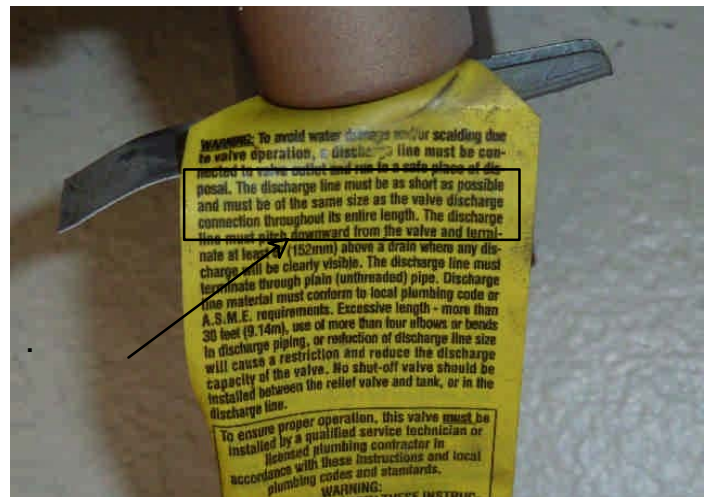
- ❖ The TPR pipe was improperly reduced in size and correction is needed. The temperature pressure relief valve is a 1" sized valve and a 3/4" discharge pipe was installed.

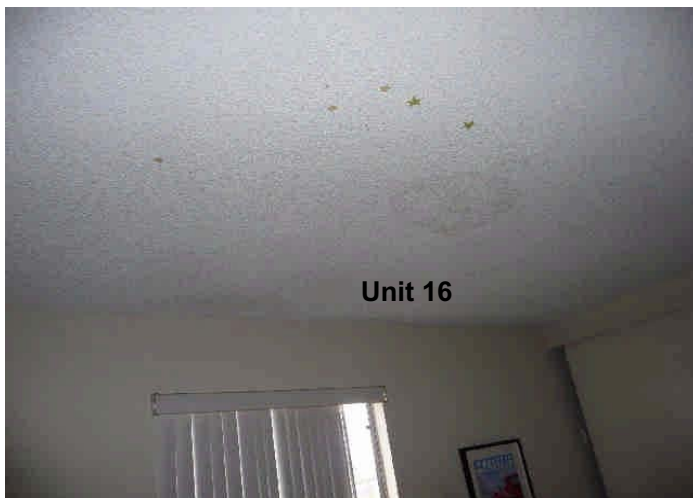
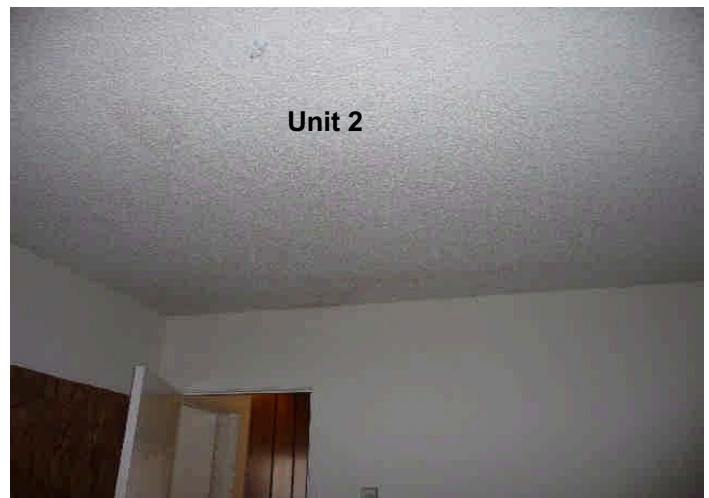
- Moisture stains were noted at the ceilings at many of the upstairs units ceilings. The adjacent roof above may have been the points of moisture intrusion (see "Roof" also). Check with the sellers for information regarding the history of any material defects relating to ceilings and walls.

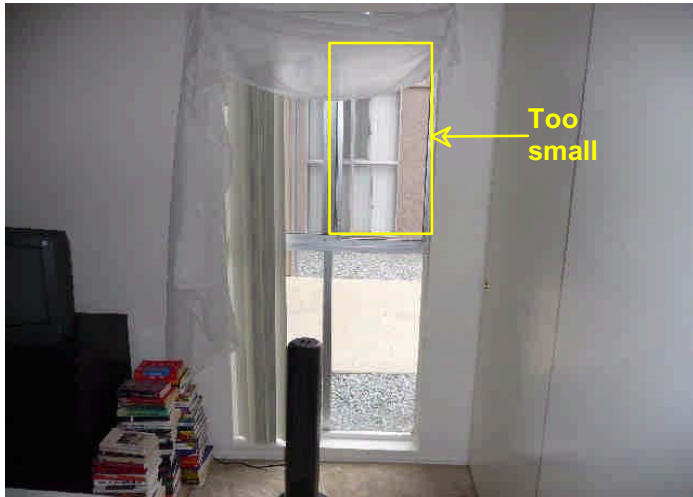
- ❖ The window at the guest bedroom of unit 3 is too small to facilitate an emergency exit or egress. The openable space of at least one bedroom window should measure 5.0 square feet with a minimum width of 20" (which would dictate a 36" height), and a minimum height of 24". This requirement is designed to facilitate an emergency exit by the occupant, and emergency egress for a firefighter wearing breathing apparatus. Although the windows may have met the requirements for the era in which the home was constructed, we advise you to have this potentially dangerous condition corrected.

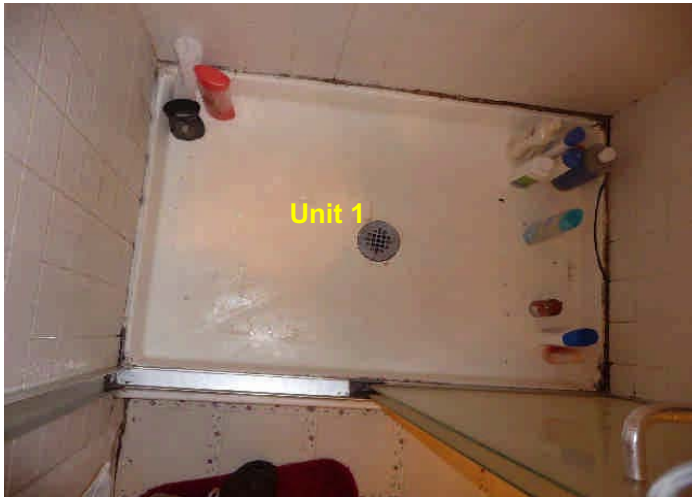
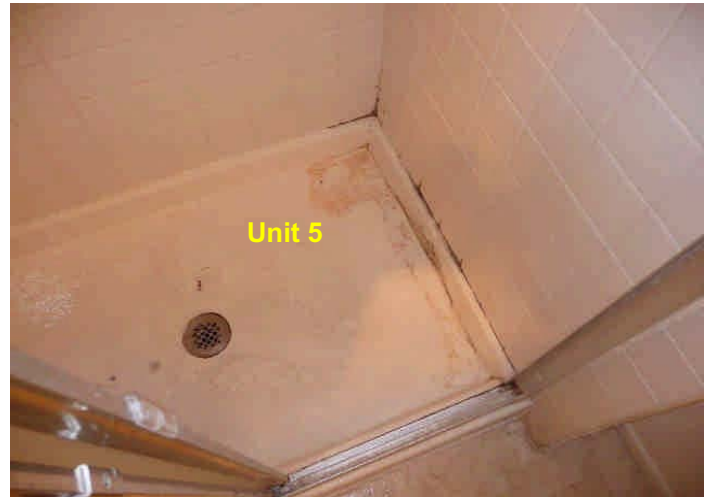
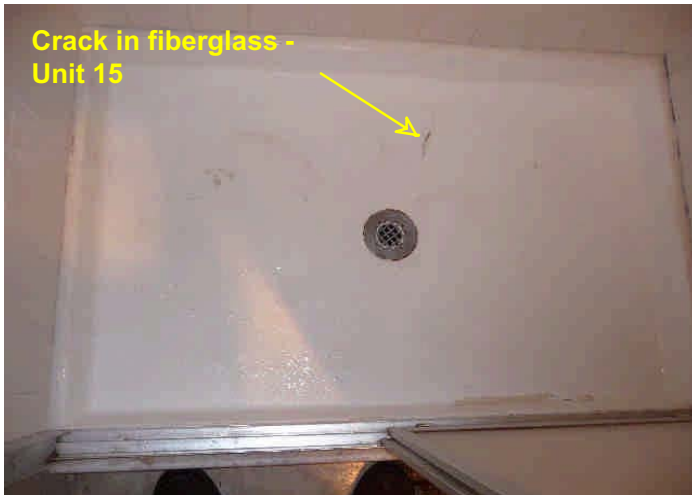
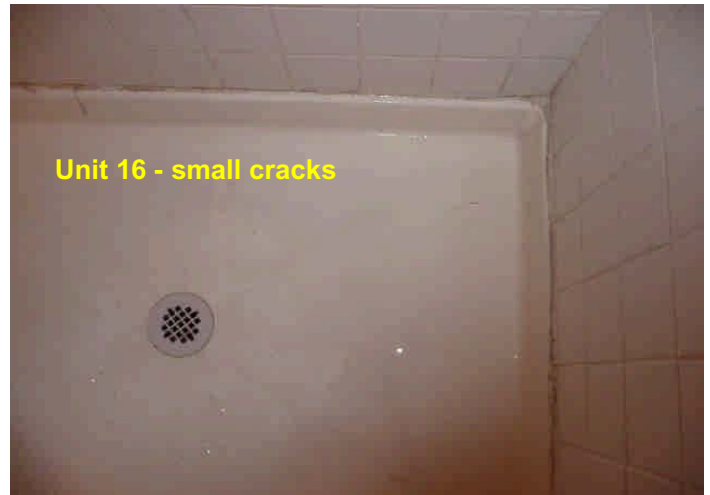
- ❖ There are cracks or openings in the molded fiberglass floors of the stall showers at units 1, 5, 15 and 16 that should be professionally repaired and confirmed as sealed to prevent moisture damage. Tiles are loose or cracked in units 1 and 5 and repairs are needed. The shower enclosures need to be cleaned in these units and in unit 11 and evaluated for repair or resealing to forestall moisture damage. Moisture stains and damage to the base of adjacent walls was noted, which confirms that the enclosures are not properly sealed.

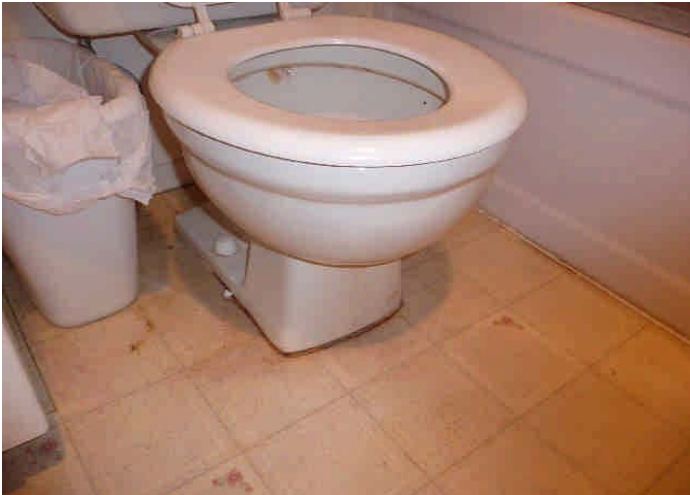
- ❖ Moisture was noted at the base of the toilet in unit 5. The toilet-to-drain connection should be evaluated by a qualified plumbing contractor to forestall moisture damage.

Moisture at base of the toilet - *Continued*

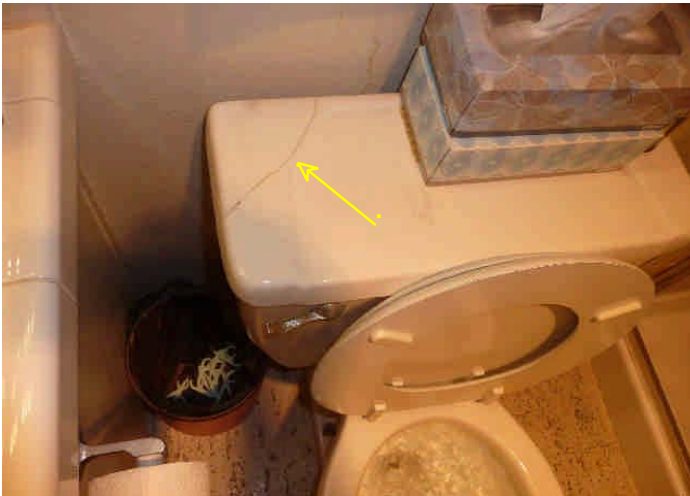
- ❖ The toilet tank top at unit 4 is cracked. Cracks or chips in porcelain toilet components go beyond cosmetic concerns sharp edges can cause serious injury. Replacement of any damaged component is needed. Note; tank covers should be exact fit for a given tank so that they do no fall or allow fill water to escape.

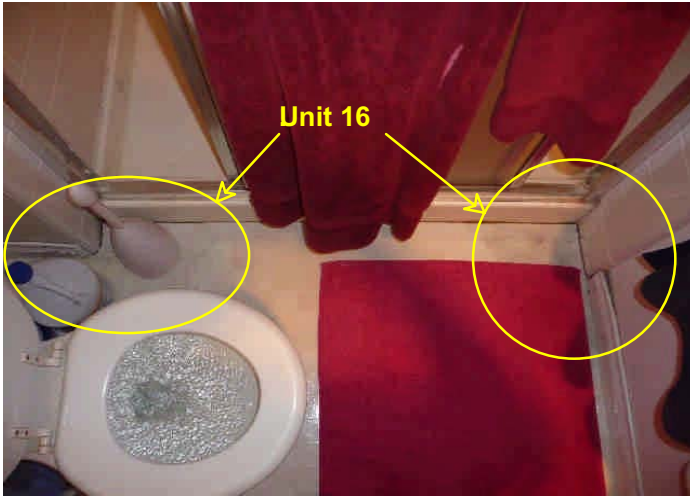
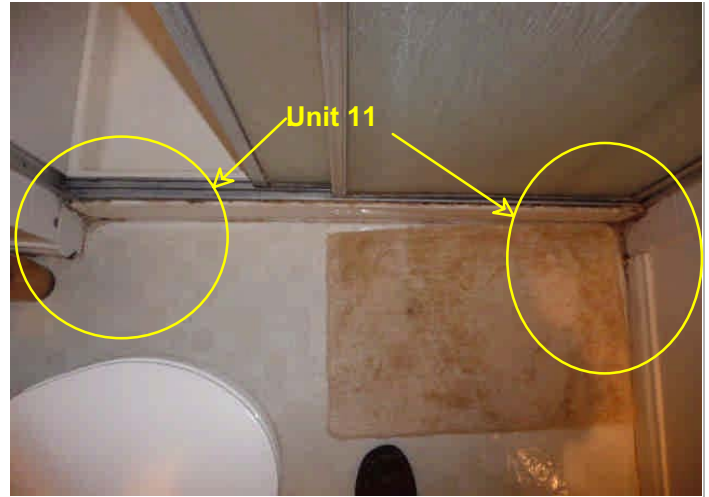
- ❖ There is moisture damage adjacent to the shower at units 1, 11 and 16 which should be evaluated and repaired. The source of any moisture causing damage should be repaired also.

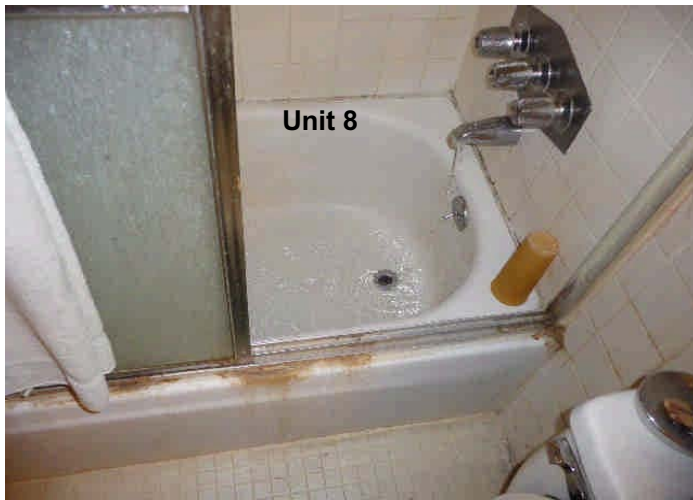
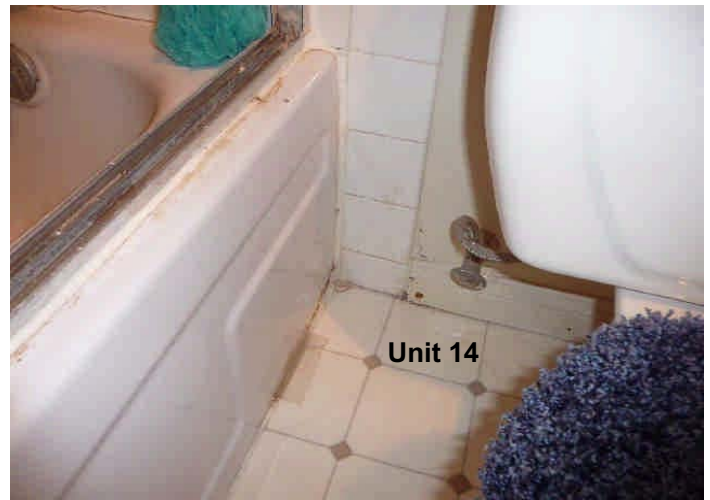
- ❖ The tub/shower enclosures and doors are corroded at unit 8 and the tub to wall connection of unit 14 are separated. These and other joints and appear to be allowing moisture to escape. The tub/shower enclosures and doors will need service to their hardware to be sealed to properly contain moisture.

Enclosure doors are corroded Leaking Tub to wall should be sealed - *Continued*

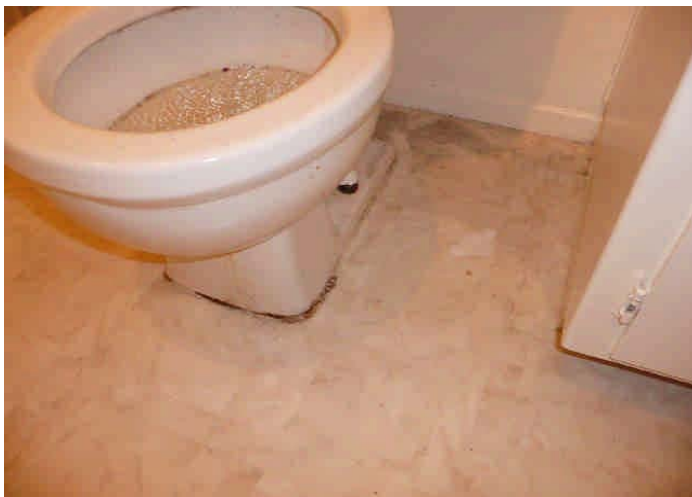
- ❖ The toilet in unit 4 runs or loses water through its flush mechanism. Repair is needed.
- ❖ Moisture was noted at the base of the toilet unit 5. The toilet-to-drain connection should be evaluated by a qualified plumbing contractor to forestall moisture damage.

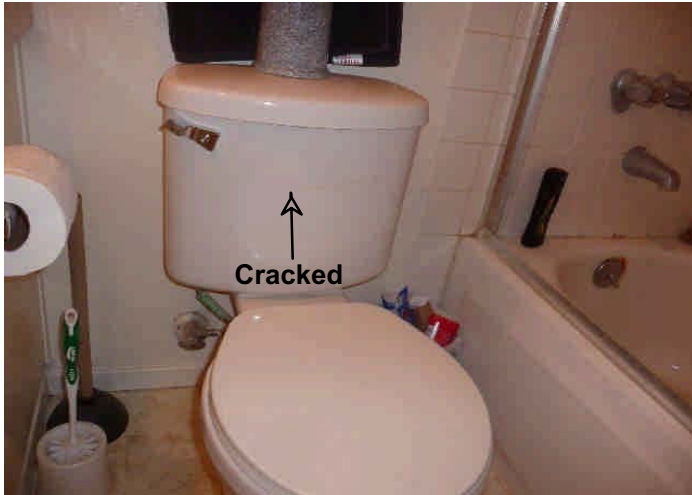
- ❖ The toilet tank is cracked, and should be replaced before it breaks completely and causes water damage.

Tank is cracked and should be replaced - *Continued*

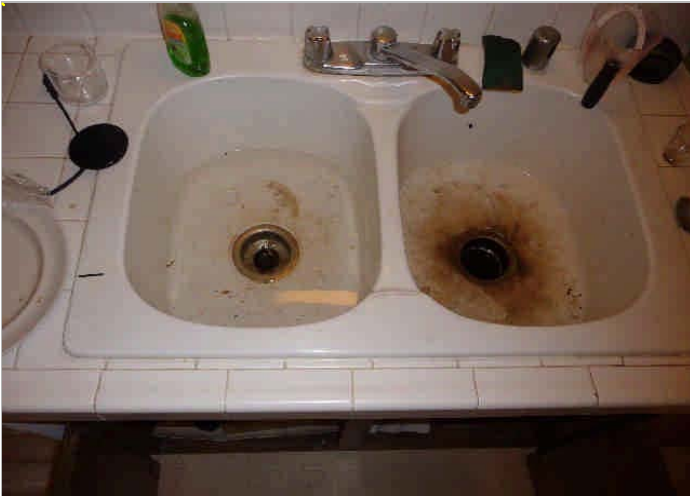
- ❖ The sink in unit 7 has heavy staining and damage and should be replaced.

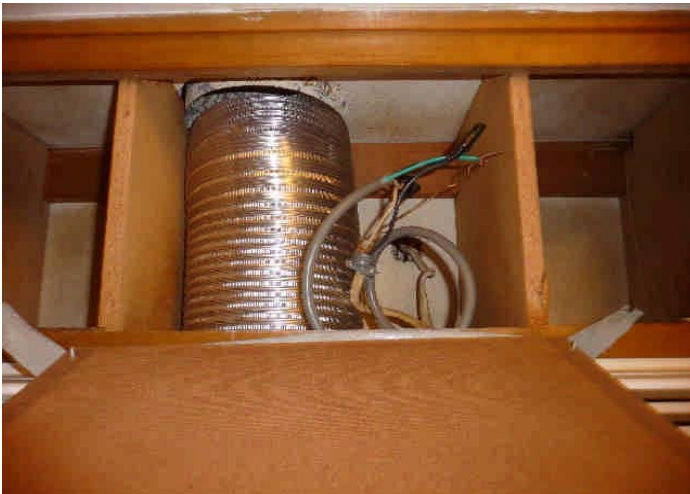
- ❖ The exhaust fan's duct is loose or not connected and electrical connection is exposed and unsafe in unit 7. A qualified contractor should secure the wiring in a proper junction box and seal the exhaust duct as needed.
