# Check It Out Property Inspections

## CONFIDENTIAL INSPECTION REPORT

3119 Avenida Arboles, La Jolla, CA 92037

7/28/2011 1:00 pm to 4:00 pm

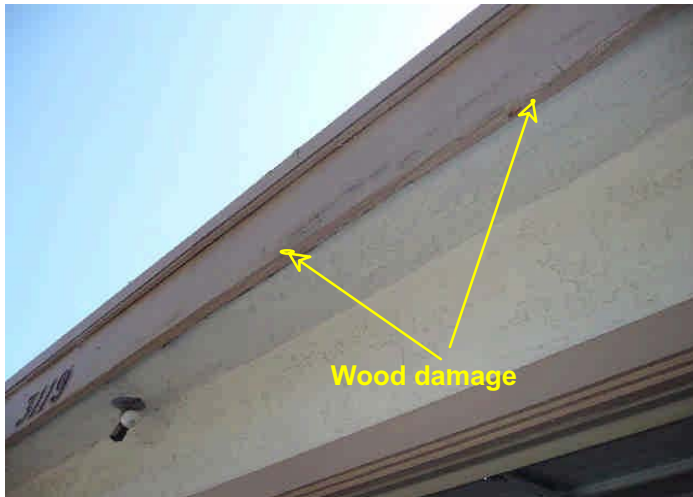
- ❖ There is moisture damage and deterioration to the wood trim at the garage eaves, front and rear. Repairs are needed. A qualified licensed contractor should evaluate the wood and trim features and replace any damaged wood. Refer also to the qualified termite inspector's report for specific action needed.

Damage to fascia board at garage Repairs needed - *Continued*

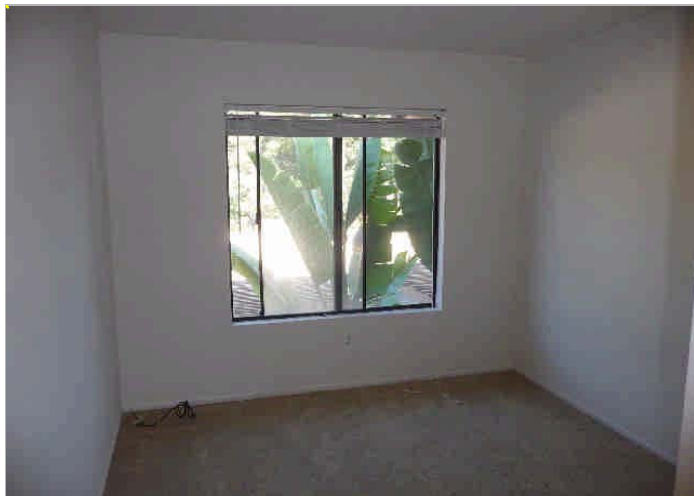
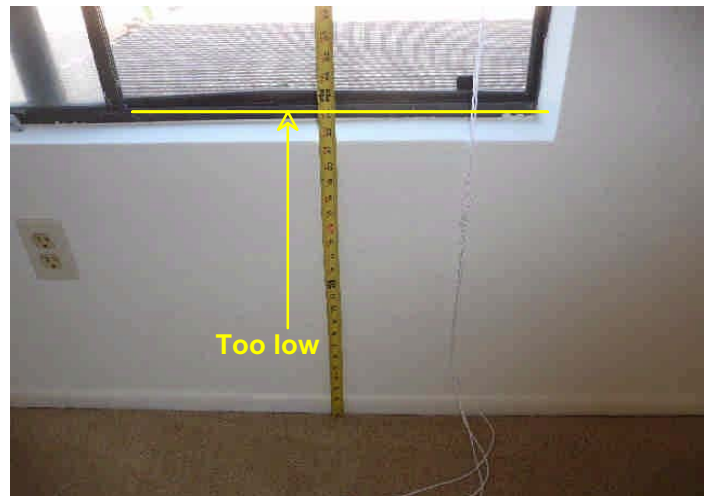
- ❖ Two of the upper story openable windows open wider than 4" and have sill heights of less than 24" from the finished floor and an unsupervised child may fall through and out. The window openings may have conformed to past building standards, however safety requirements have changed; windows near the floor at above grade rooms are now restricted from opening more than 4". The windows' sill heights and openable space will be a safety hazard to small children. Consult a qualified licensed contractor for a solution to keep children safe while providing the necessary clear opening of the windows for emergency egress or escape.

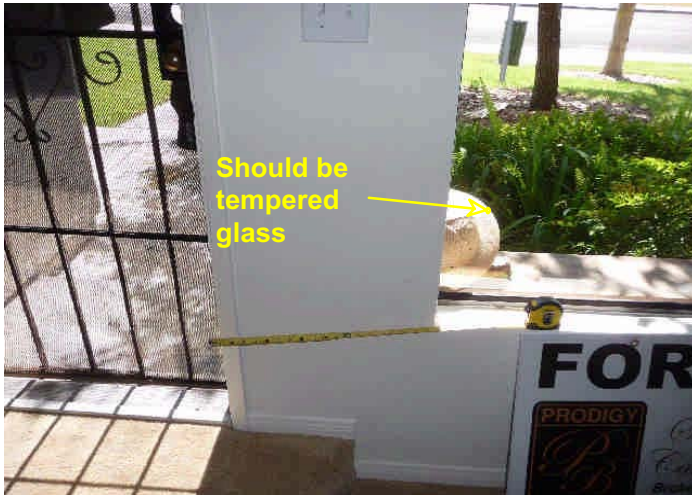
- ❖ The window next to the exterior door at living room /entry did not appear to be safety glazed. This is considered a potentially hazardous location. Windows within 24" of the strike/closing side of a door are to be tempered glass for safety. Verification of tempered glass at this location, or subsequent replacement as necessary, is advised. Consult a licensed glazing contractor for further evaluation.

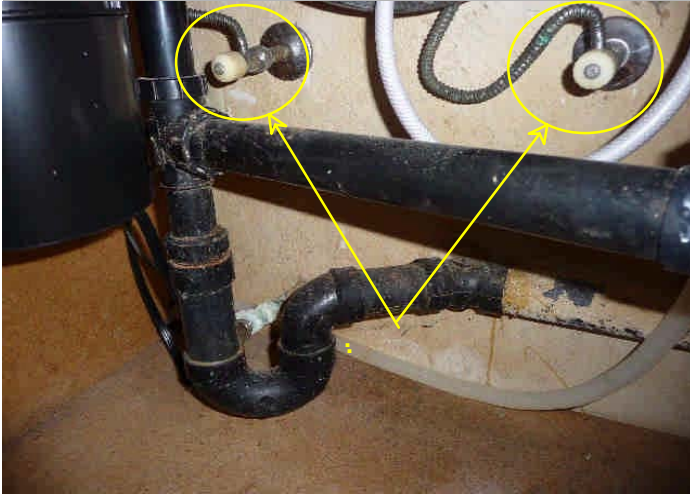
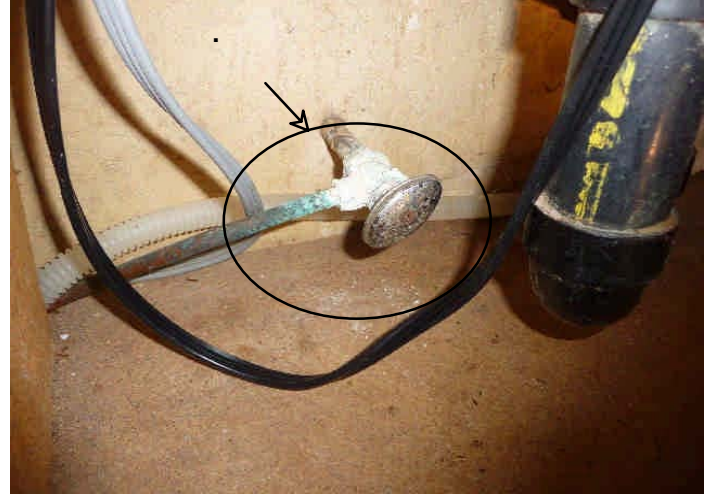
- ❑ Corrosion was noted at the water supply shut-off valves at refrigerator water supply, at toilets and under sinks. While no active leaking was noted at the time of the inspection, corrosion is the precursor to a leaking or inoperable valve. Replacement of any corroded supply valves is recommended as a preventative measure.

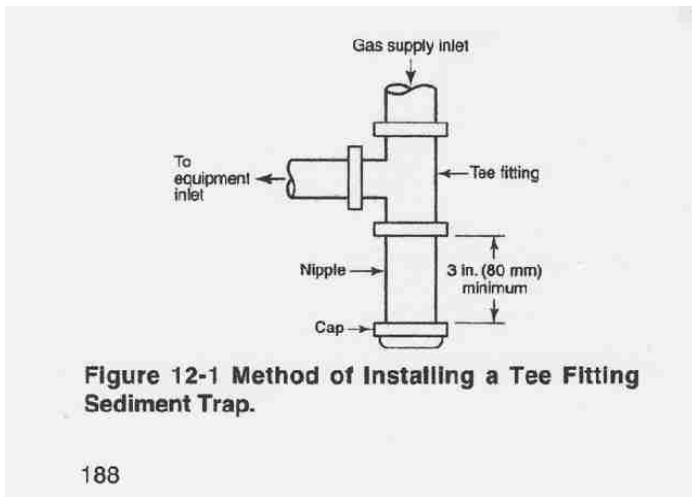
- The gas control valve and its connector at the water heater appeared functional, however the gas piping upstream of the shut-off valve on the water heater did not include a drip leg/sediment trap. A sediment trap is normally required by the water heater manufacture, however the installation guidelines were not available and this could not be confirmed. The absence of the sediment trap may nullify a manufacturer's warranty. Refer to the water heater manufacturer's installation instructions to verify the requirement for a sediment trap, and have the feature installed by a licensed plumbing contractor if to provide safe operation and warranty coverage.

No drip leg-sediment trap - *Continued*

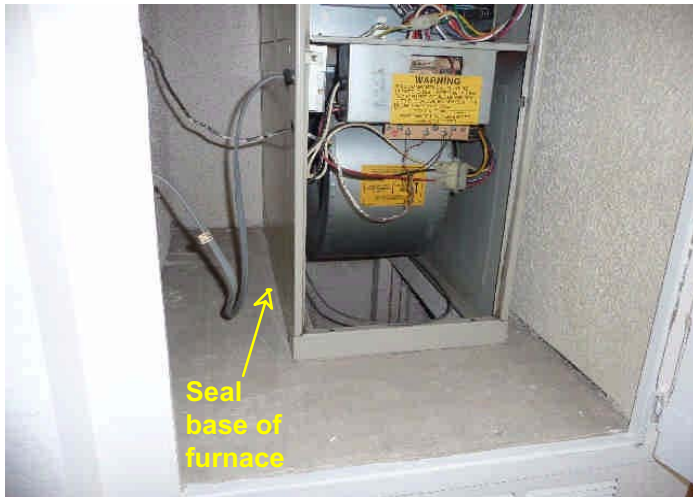
- \* The furnace responded to normal controls and was operational during our limited evaluation.
- ❖ *Needs Service or Safety Item*  
The base of the gas furnace, at the junction of metal cabinet to wood return air platform or compartment, is not adequately sealed. Spaces or gaps could allow the bi-products of combustion to contaminate the circulating air. A qualified HVAC contractor should correct this potentially hazardous condition.

**Base of gas furnace must be sealed Functional furnace - Continued**

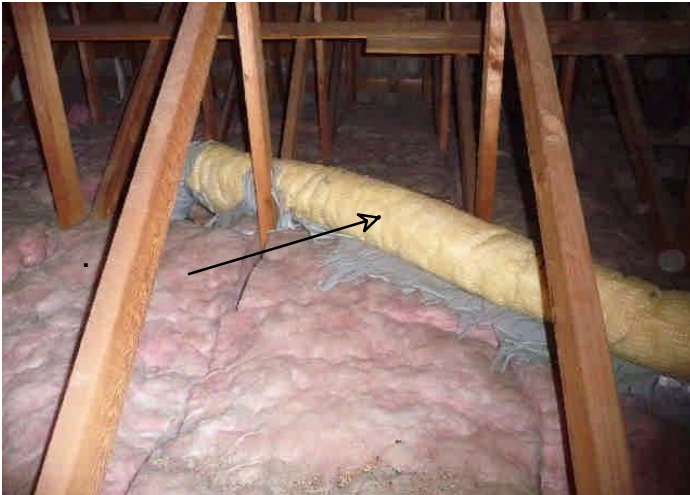
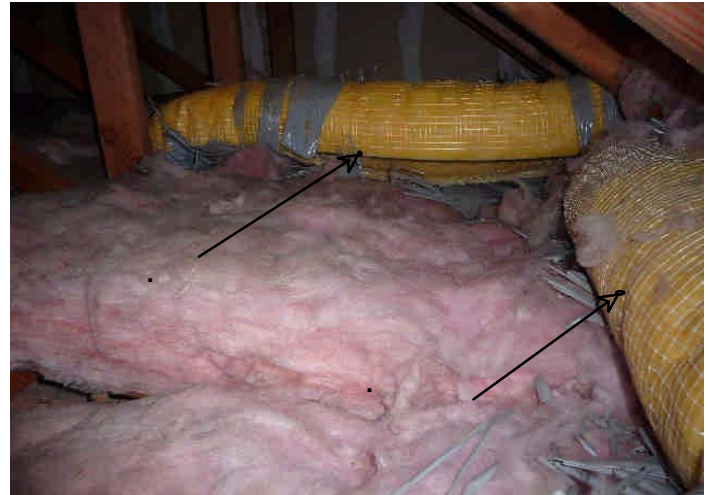
- ❖ The flexible ducts are an early generation type that have been found to be susceptible to damage from exposure to high temperatures and ultra-violet light which directly or indirectly shines on the ducting through attic vents or other openings. The outer sleeves have deteriorated from portions of the ducts in the attic and the damaged sections should be replaced. We recommend that all of the ducting be considered for replacement.

U V damaged Should be replaced - *Continued*

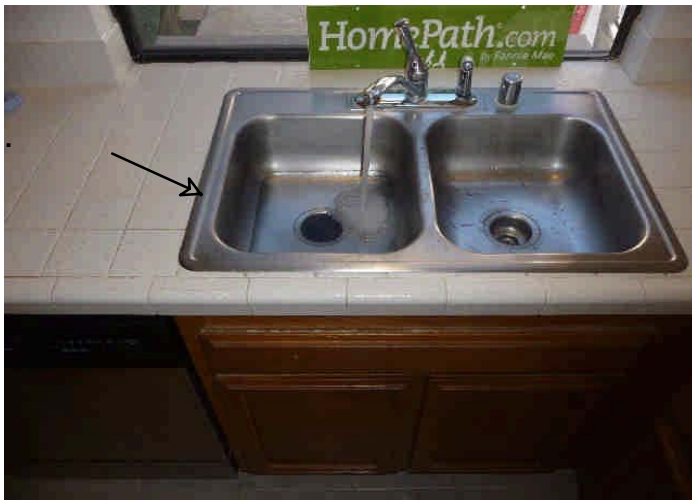
- ❖ The seam between the sink and the counter top needs to be caulked or sealed to forestall moisture intrusion. Water drips through to cabinet below.

**Sink-to-counter needs to be re-sealed - Continued**

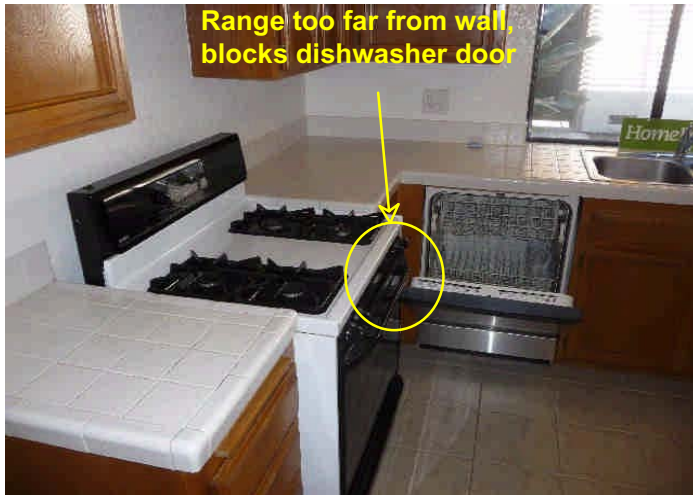
- ❖ An anti-tip bracket is needed for safety. Anti-tip brackets are to prevent a range/oven from being tipped if a child were to climb or pull on it.
- ❖ The left and right rear burners on the gas range did not light. The burners, igniters and/or valves should be cleaned and serviced as needed.
- ❖ The gas supply pipe and/or valve prevents the proper placement of the appliance: Range too far from wall, blocks dishwasher door. The gas supply should be corrected by a qualified plumber.

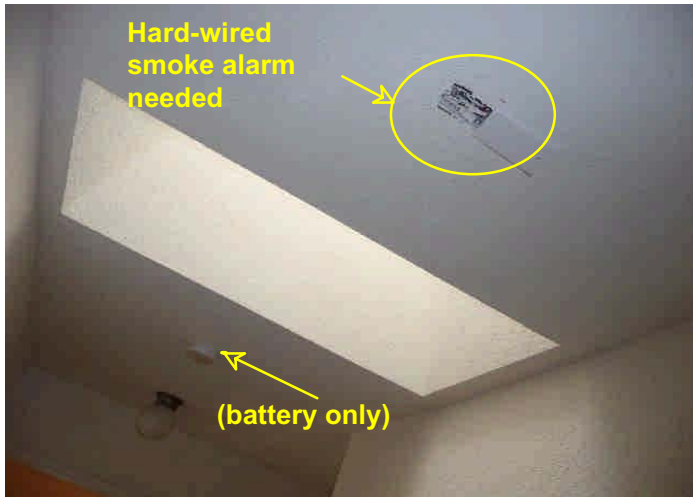
- ❖ Hard-wired smoke alarms have been required for many years in the bedroom hallway location, and in recent years at bedroom and other floor level locations. The smoke alarm at the bedroom hallway is battery powered only and should be replaced with a hardwired smoke alarm for safety.

**Hard-wired smoke alarm required - Continued**

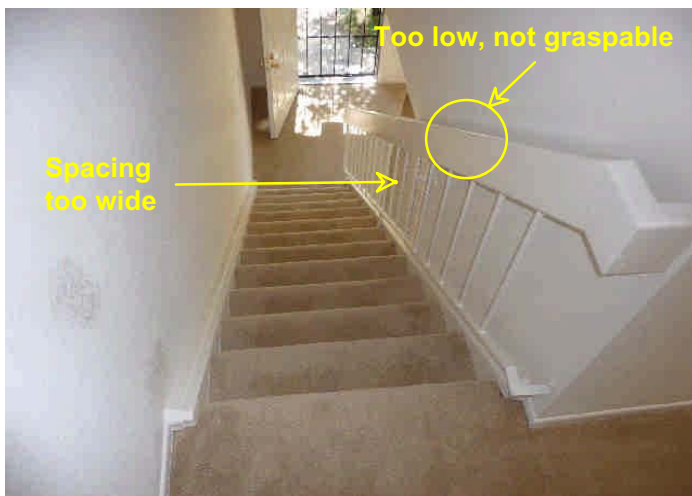
- ❖ The stair hand rails/guard rails, while possibly compliant with building standards in the era of their installation, do not meet today's safety standards; the handrail is too low and not properly graspable, and handrail and guardrail include balusters or openings which are too wide. It is advised to upgrade the hand rail/guard rail for safety.  
Stair handrail height should be between 34" and 38" above the toe of the steps. Standards for grip dimensions require a handrail on steps to have a circular cross section of no more than 2" and perimeter dimension of not more than 6.25" so that a person can grab it in the event they need to steady or catch themselves while ascending/descending the stairs. The balusters or pickets in the stair and/or landing railings/guard rail are wider than the current standard of 4" apart, and a small child may pass through and fall or become stuck. Upgrading for safety is advised.

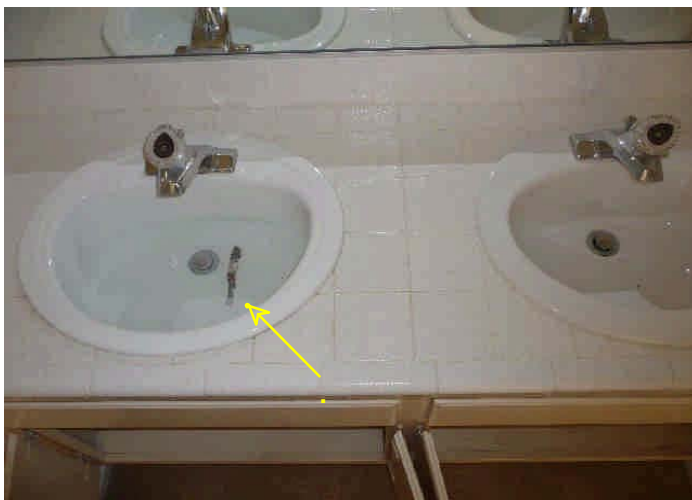
- The left/east sink is corroded at its drain, overflow and/or underside. The life expectancy of this type of metal sink is relatively short as the edges of the metal at drain openings and overflow drain channel become corroded more rapidly than other surfaces. No leaking was visible at the time of the inspection, however you may wish to replace it or monitor for leaks in the future.

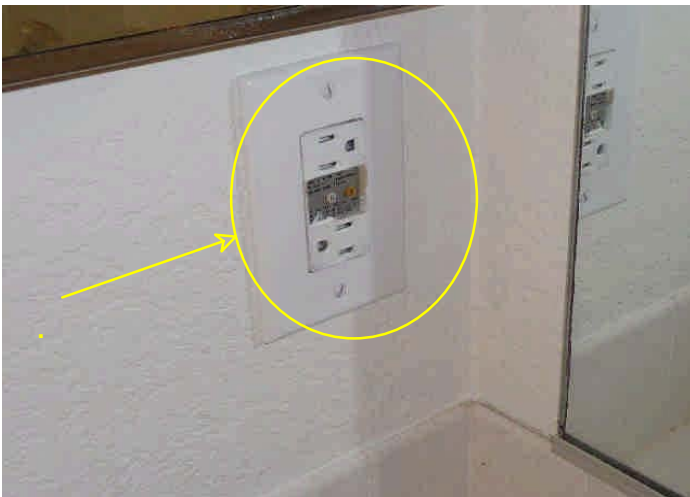
- The GFCI outlet, or Ground Fault Circuit Interrupter device, is old. GFCI devices are subject to wear from weather and age, these older ones may not reset properly. The latest generation of GFCI receptacles have proven to be more reliable. We advise replacing all of the GFCI outlets with new ones at this time for dependable safe operation.

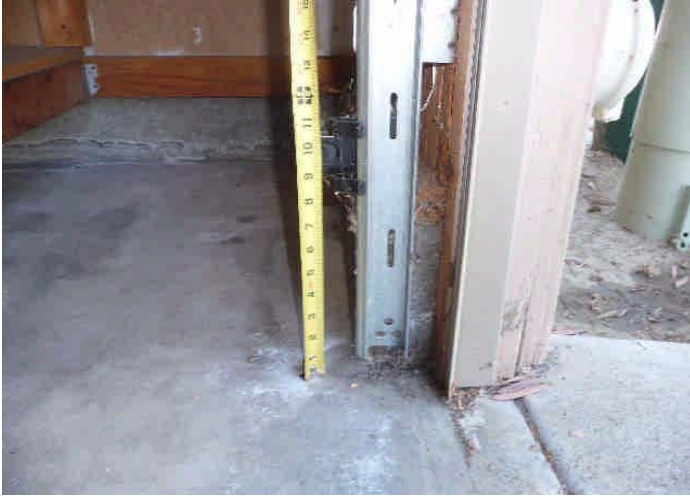
- The garage door opener is functional. The door reversed with sensors, and when resistance was applied.
- ##### *Needs Service or Safety Item*
- ❖ The infra red auto-reversing sensor mechanisms are functional but located higher than the recommended 6" above grade. The sensors should be lowered for safety.

Sensors higher than 6 inches above grade - *Continued*

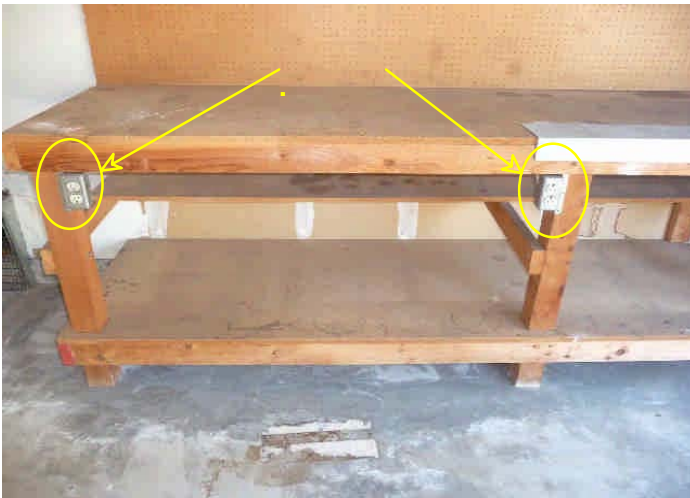
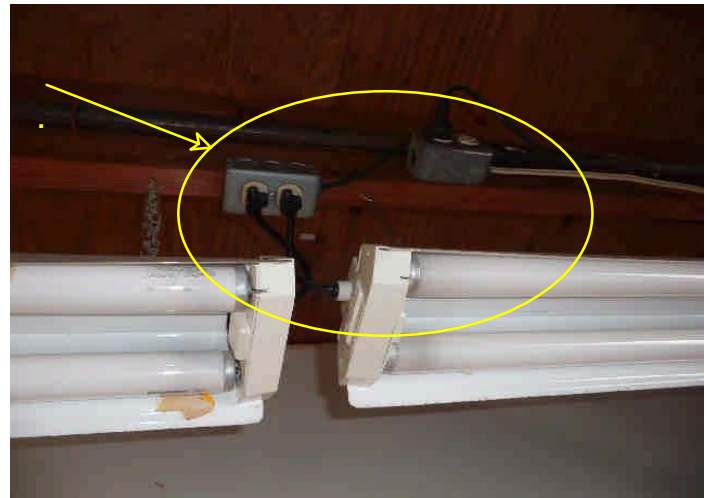
- ❖ The added garage outlets should be upgraded to have ground fault protection, which is mandated by current standards and is an important safety feature.

- ❑ One of the outlets includes (GFCI) ground-fault circuit interrupter protection. The GFCI (Ground Fault Circuit Interrupter) outlets are older. GFCI devices are subject to wear from weather and age, and the latest generation of GFCI receptacles have proven to be more reliable. These older ones may not reset properly. We advise replacing all of the GFCI outlets with new ones at this time for dependable safe operation.
- ❑ One of the outlets includes (GFCI) ground-fault circuit interrupter protection. The GFCI (Ground Fault Circuit Interrupter) outlets are older. GFCI devices are subject to wear from weather and age, and the latest generation of GFCI receptacles have proven to be more reliable. These older ones may not reset properly. We advise replacing all of the GFCI outlets with new ones at this time for dependable safe operation.
