# Check It Out Property Inspections

## CONFIDENTIAL INSPECTION REPORT

2215 Papagayo Lane, San Diego, CA 92130

6/18/2014 10:00 am to 2:45 pm

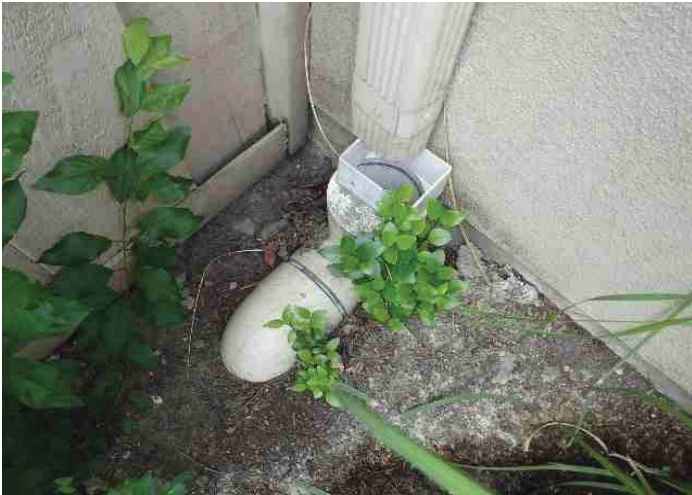
- ❖ The rain gutter down-spout at the left side does not connect to the drain and water will discharge onto the wall and foundation exposing the building to excessive run-off. Repair and ensure that drainage from the roof and surface grade is directed into sub-surface drain(s) directed to the street or municipally approved termination point.

Discharges at foundation Correction needed - *Continued*

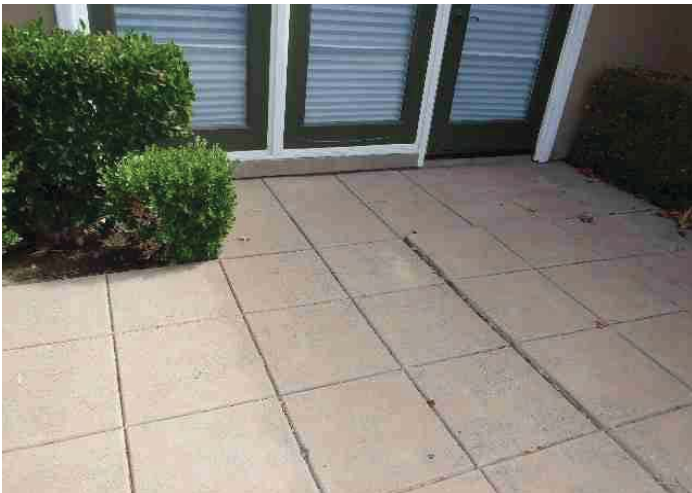
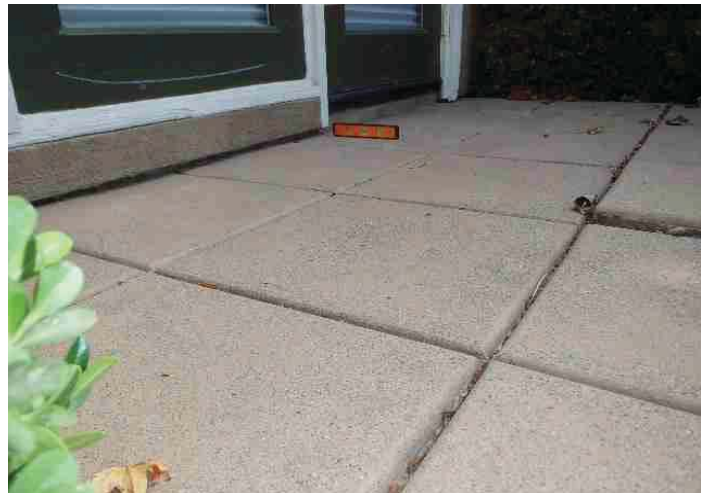
- ❖ There are portions of the right rear concrete patio where water will be trapped or directed toward the house instead of away from it as required (see "Hardscape" below also). Differential settling of the foundation and moisture intrusion to walls and floors can occur with adverse drainage conditions. Concrete/hardscape and soils should slope away from a structure at a rate of 6" in 10' (or 5% where area is restricted) to prevent moisture damage and differential settling. A qualified contractor should evaluate the hardscape and site drainage and correct as needed.

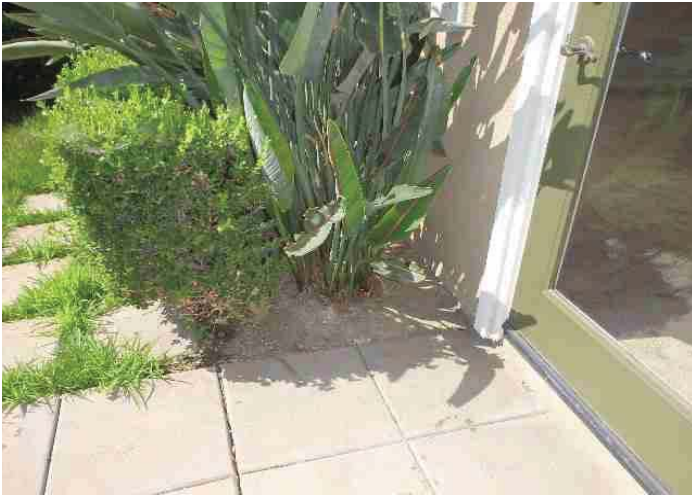
- ❖ Surface grade is too high against the house at the left/east side: the planter bed has high soil levels that will trap water against the walls of the residence. Exterior grade contacting stucco will lead to moisture damage to walls and floors. Lower the grade/soil to 4" below the bottom edge metal (weep screed) of the stucco

siding and ensure that the grade slopes away from the structure.

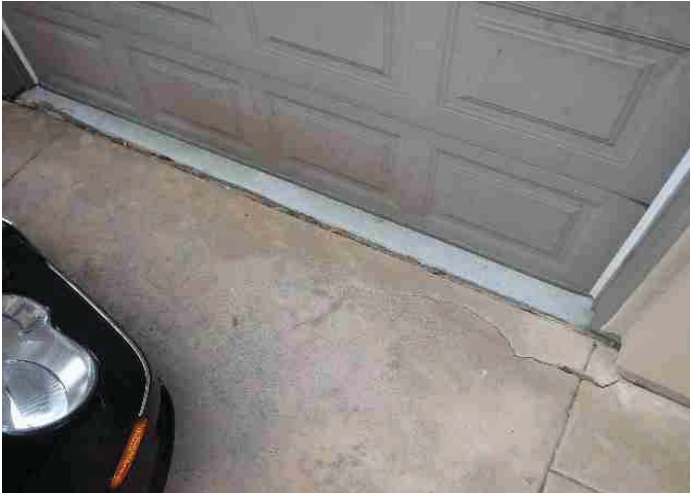
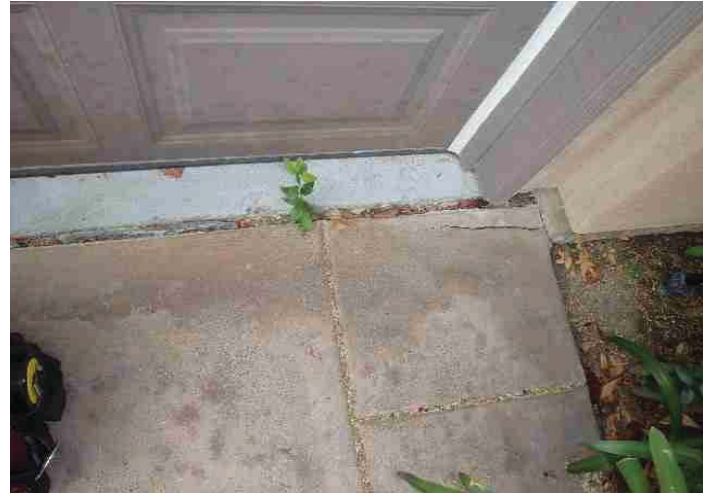
- ❖ Displacement and cracking were noted at the concrete driveway. There are cracks and separations which will allow moisture to enter and exacerbate the problems, and there are offsets that could prove to be

trip-hazards. Repair of the driveway is advised. Enlist one of more qualified licensed contractors for an evaluation and cost estimates to repair or replace the driveway.

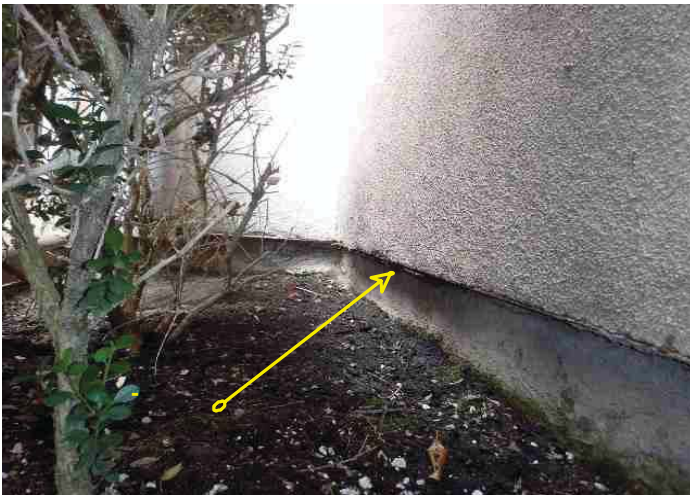
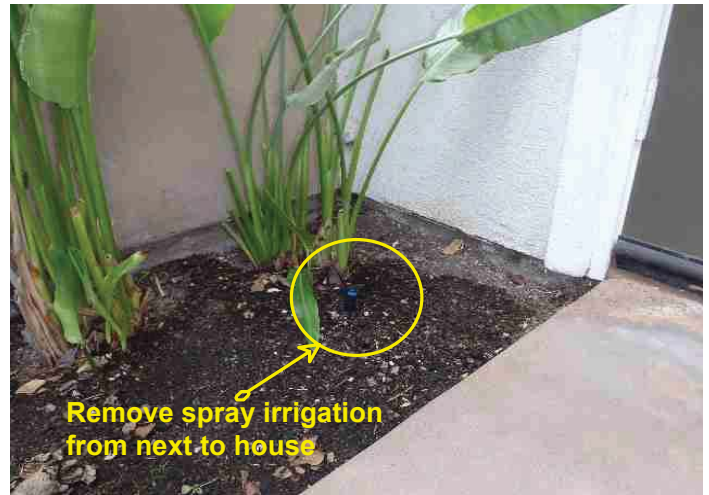
- ❖ There is moisture staining to the stucco siding and corrosion of the stucco weep screed at the base of some of the exterior walls, primarily at the front of the house, apparently from errant irrigation sprinklers. Exposing the exterior walls to regular moisture will damage the stucco and moisture may eventually make its way through the moisture barrier of the siding and into the walls. Repair or alter the irrigation as needed to keep water from spraying onto the house.

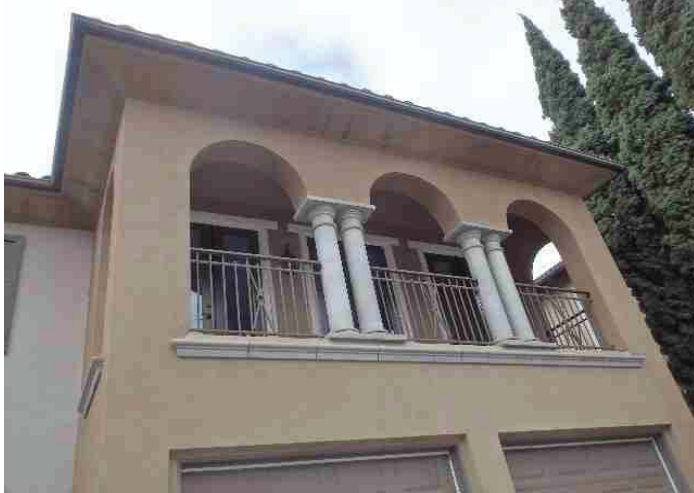
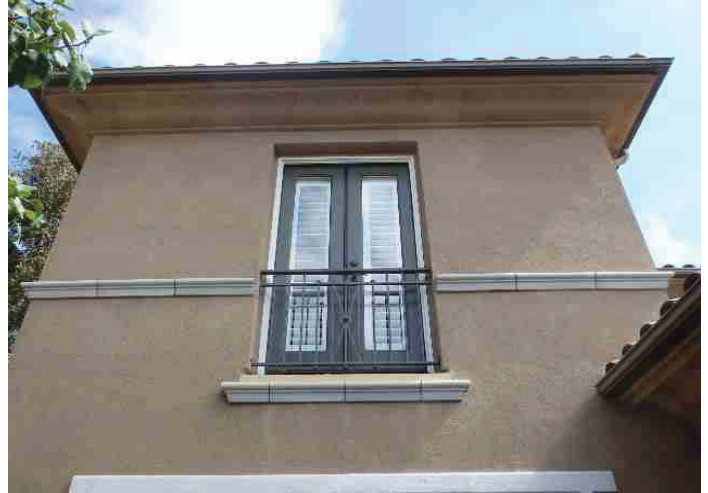
- The walls are moisture-stained along the upper portions (coved eaves) at most all sides which appeared to be primarily a result of run-off from the roof and flashings and seepage or dripping from the rain gutters at the roof's edges. Typical nightly dew collection on stucco features and soffit or detail corners can cause unavoidable staining also. The roof system rain gutters need service (see below) to forestall water damage to the wall cladding.

Run-off stains on upper walls and coved eaves Service roof and rain gutters - *Continued*

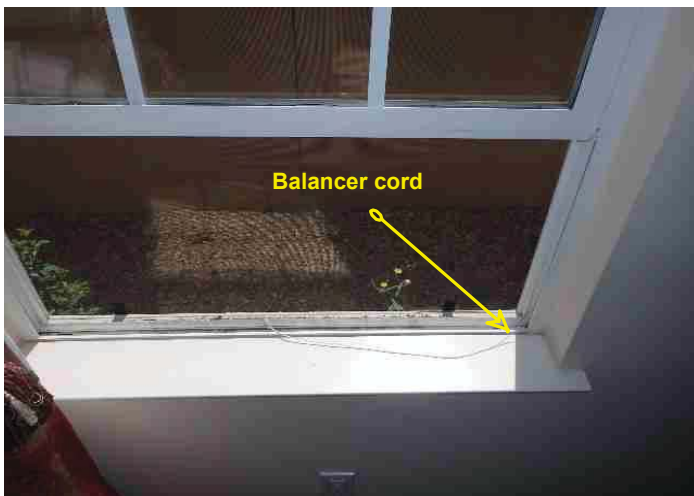
- ❖ The balancer (spring and cord mechanism in the window frame to keep a vertically sliding window at set placement) of the single hung window at the dining room is broken and should be replaced in order for the window to function properly.

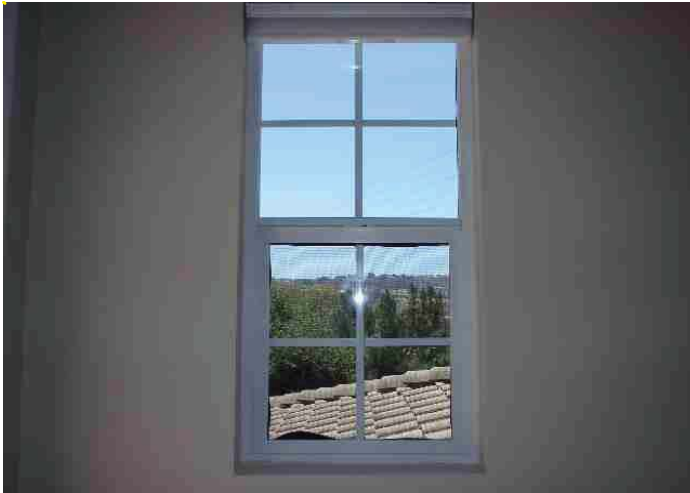
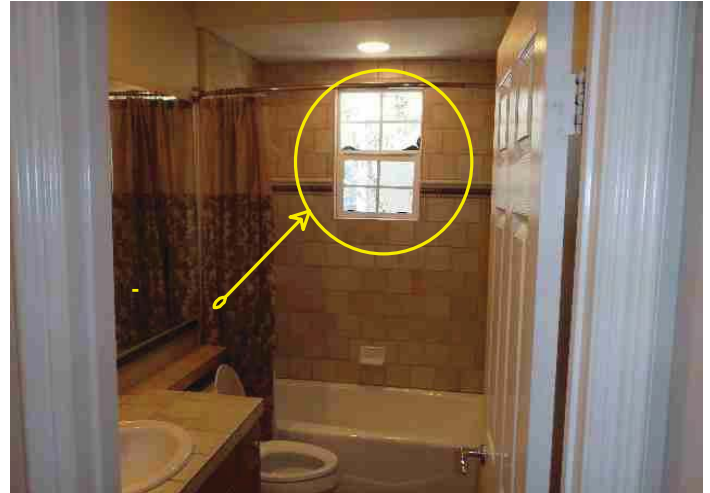
- ❖ The seals at some of the dual-paned windows (lights in the upstairs media room, bathrooms and in master bathroom) are distorted and have migrated into the clear light space of the dual paned windows. This indicates failing hermetic seals. While the distorted seals may not affect the weather-proofing function of the glazing it will obviously be a cosmetic deficiency. Consult the window manufacturer or a qualified licensed glazing contractor (C-17) for an evaluation and replacement or repair of the windows as needed.

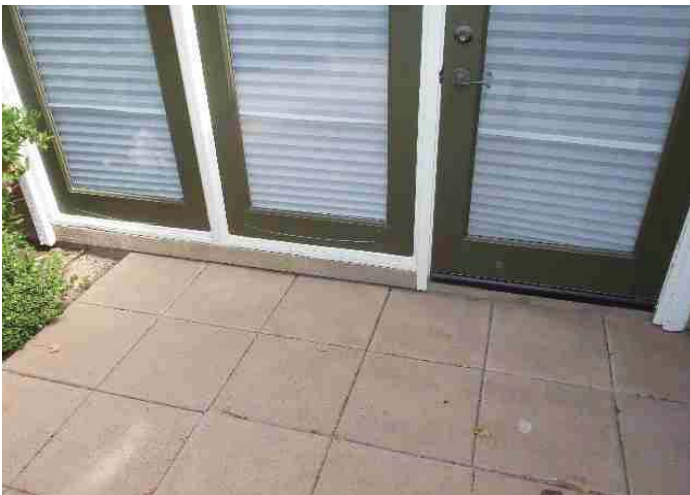
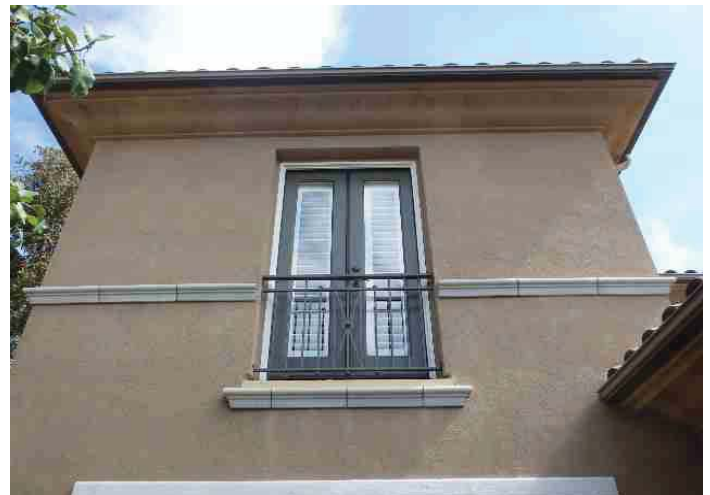
- ❖ The exterior doors and side lights at the downstairs extra room/den and the upstairs rear bedroom are moisture damaged and should be repaired or replaced as needed. Refer to a qualified termite inspector for a determination as to whether the doors will need complete replacement or whether repair is possible.

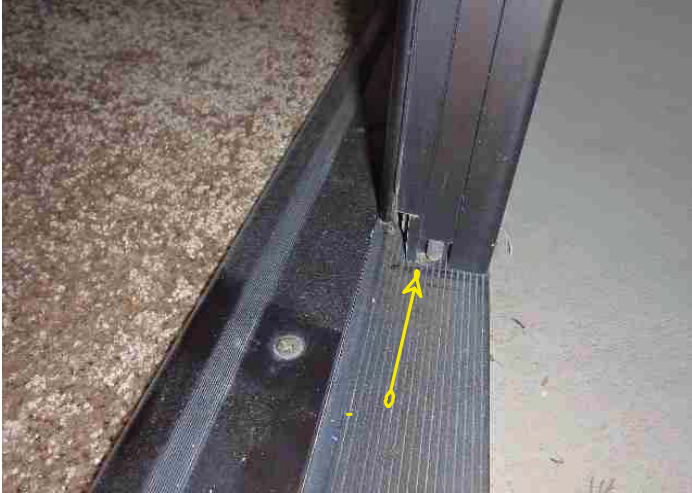
- ❖ One of the dual-paned exterior doors at the upstairs rear bedroom appears to have a failed hermetic seal. This was evident by fogging or haze within the dual-paned glazing. Replacement is advised. Consult a licensed (C-17) glazing contractor for a second opinion. Note; due to lighting, dust and dirt, we may not have located and identified all windows or doors with failed hermetic seals and a glazing specialist may well discover additional defective glazing.
- ❖ One of the master bedroom door's vertical bolt hardware is not functional. The door or hardware will need adjustment to function.

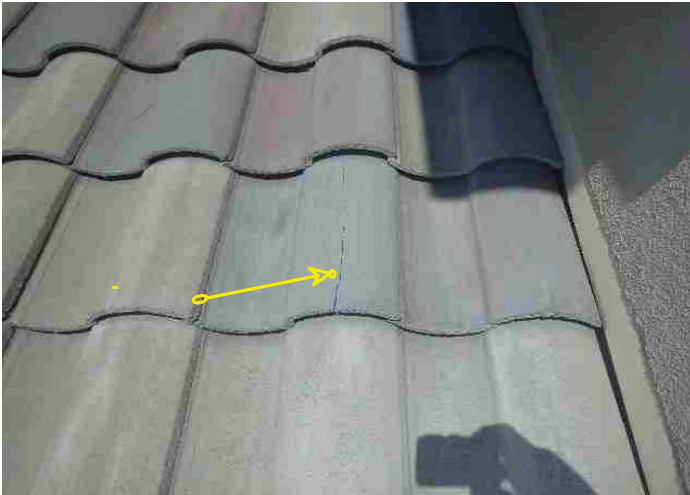
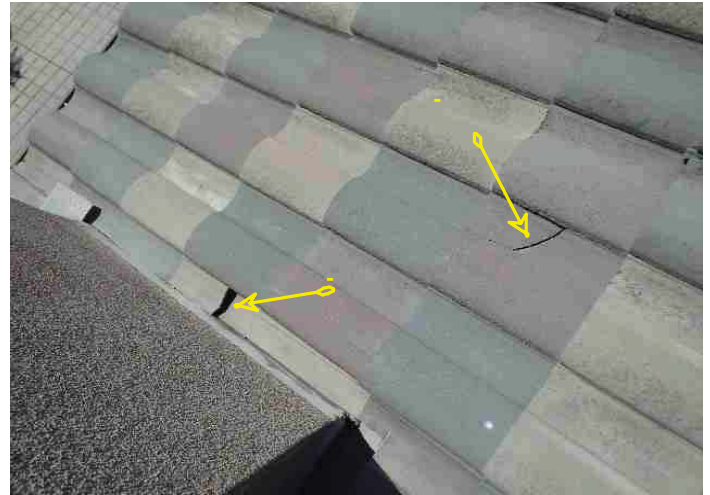
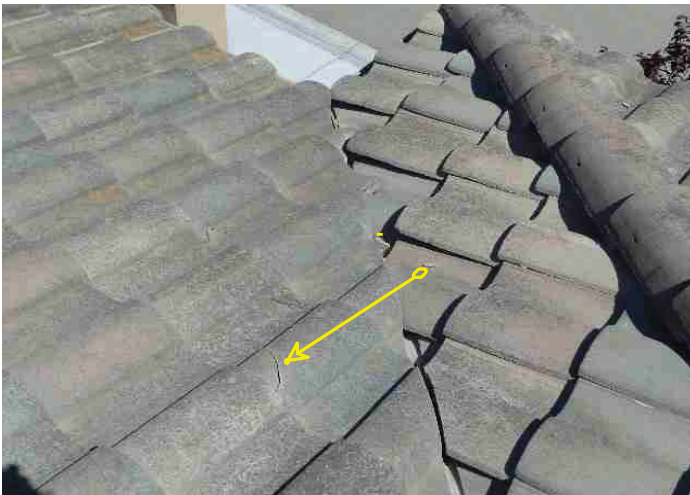
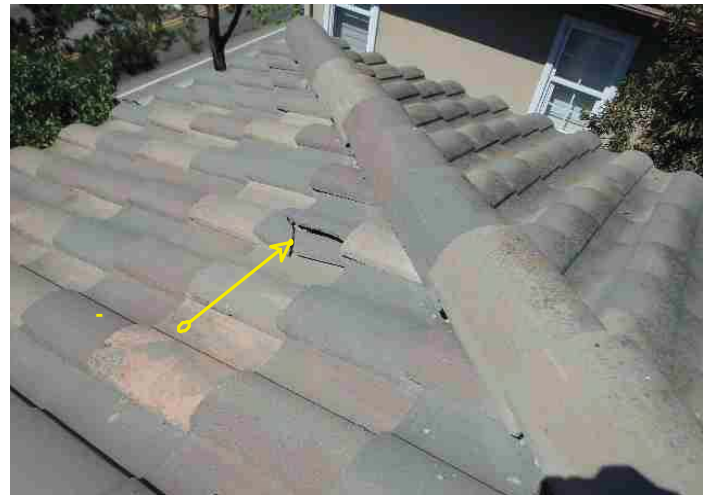
Cracked tiles Replace - Continued

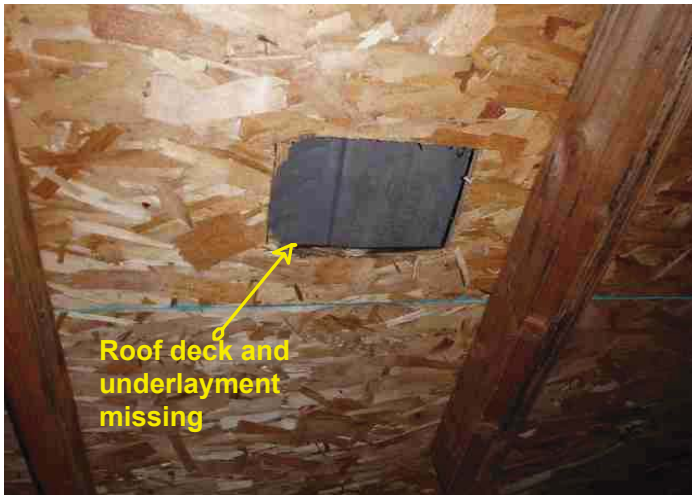
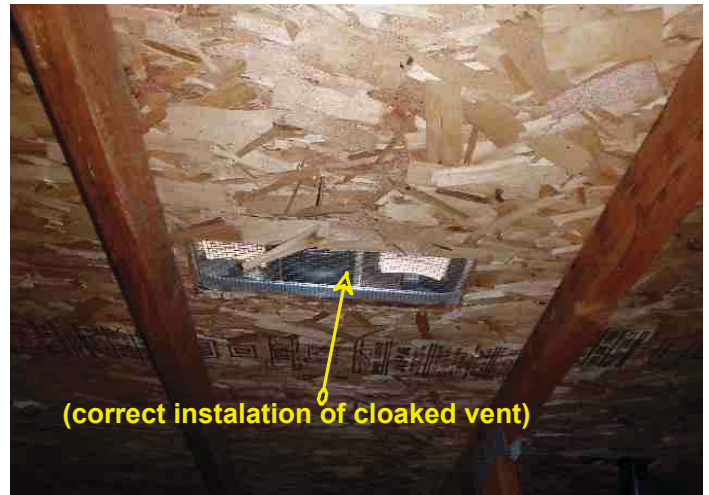
- ❖ The roof's underlayment (AKA "felt") does most of the water-proofing of a tile roof and the underlayment is the waterproof membrane. Usually the underlayment is covered by tiles and not visible. Underlayment and the roof deck was missing or has been cut away in at least one location accessible for inspection, apparently a mistaken location for a cloaked attic vent. The area of the roof soul be evaluated by a licensed roofing contractor and repaired as needed.

**Underlayment and deck missing or cut away Repair needed - Continued**

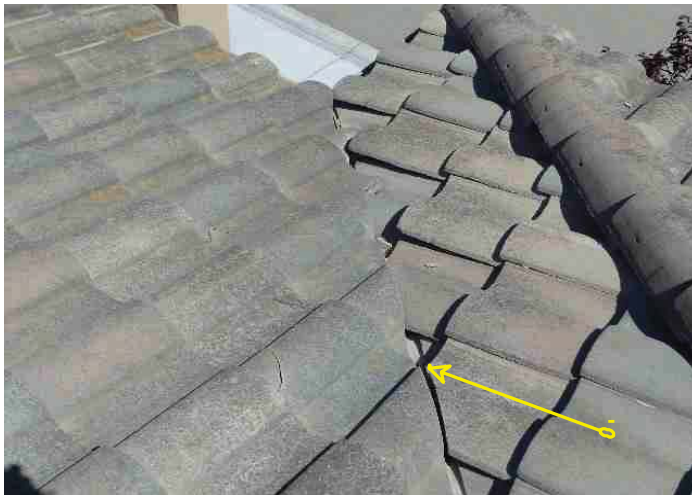
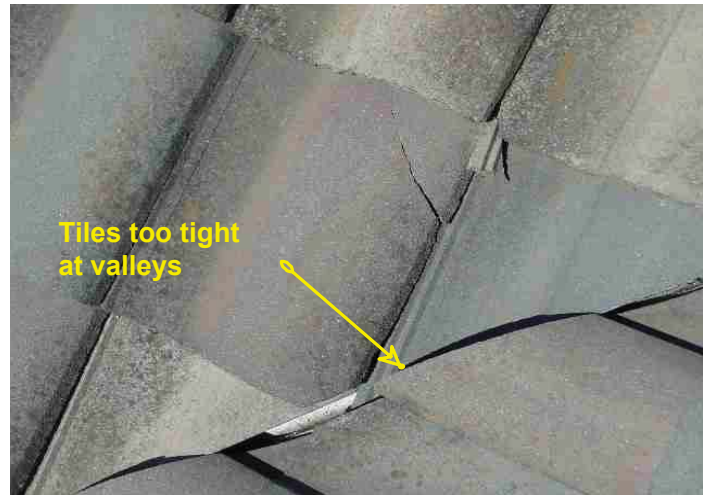
- ❑ The roof tiles at valleys were set too close to the center of the metal valley flashings and the valleys are subject to trapped debris and blockages. Modern roofing standards require greater clear space between roof tiles at valleys to allow unobstructed drainage. Blocked valleys will direct water back up or to the side and the water may penetrate the roof system. Enlist a qualified licensed roofing contractor to upgrade the tiles at valleys as advised. This may include cutting the concrete tiles back along the valleys to provide clearances needed. Seek evaluation and the opinion of the roof valleys by a licensed roofing contractor and upgrade as advised.

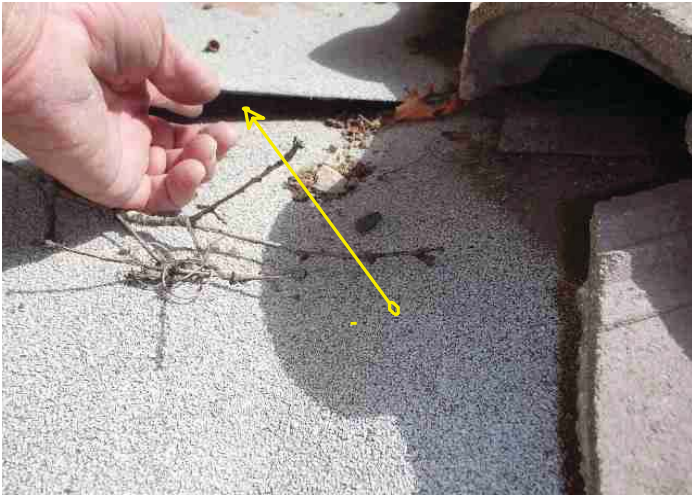
Seams separated Repair needed - *Continued*

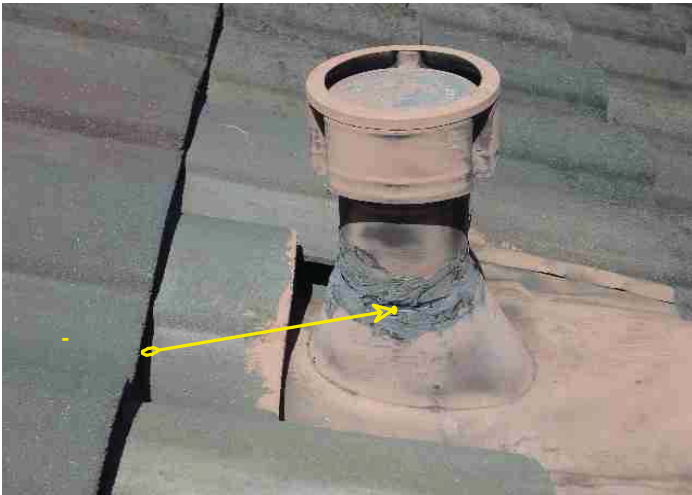
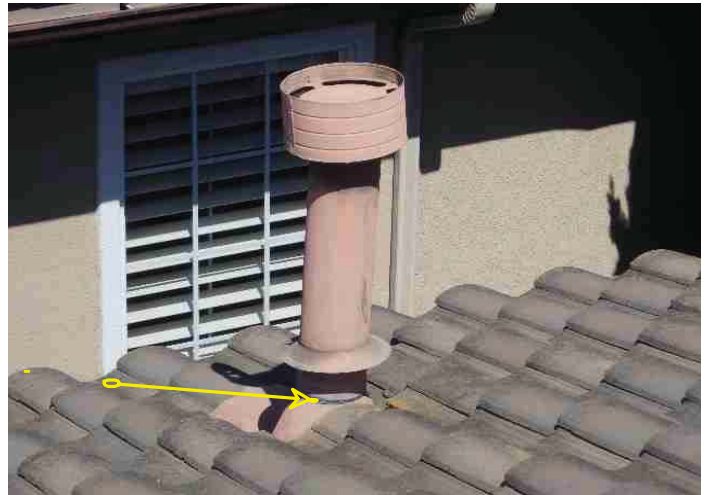
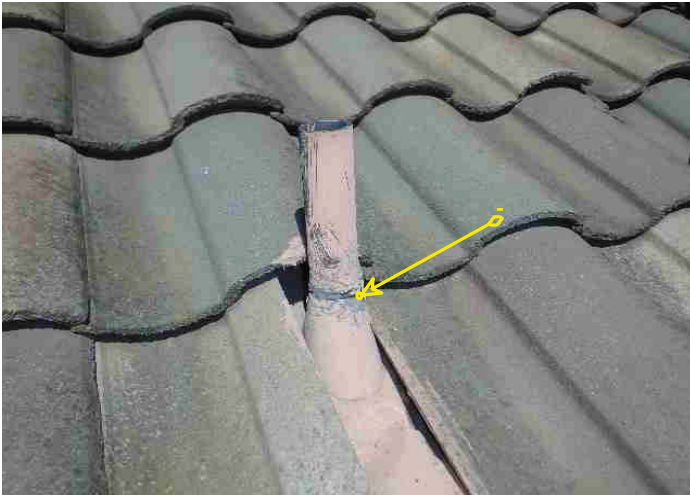
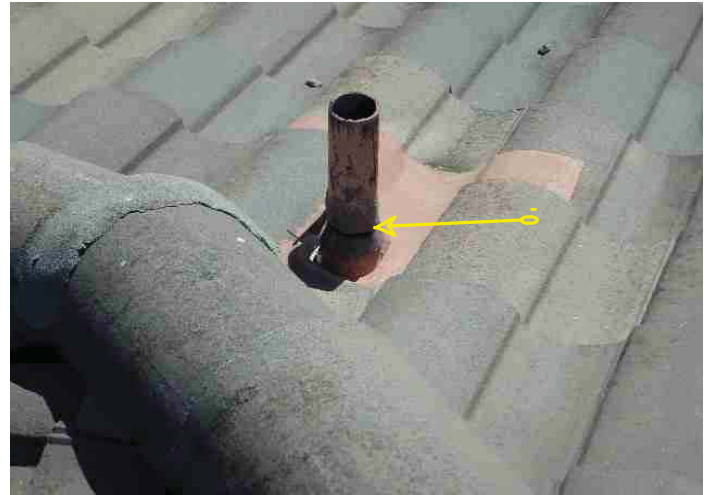
- ❖ Flashings are the components (usually metal) that seal vents and other roof penetrations, the most common points of leaks. The roof flashings need to be sealed at vent pipe to flashing connections. Enlist a licensed roofing contractor to perform a maintenance service of the vent pipe flashings.

Need to be sealed at vent pipes Roof flashings - *Continued*

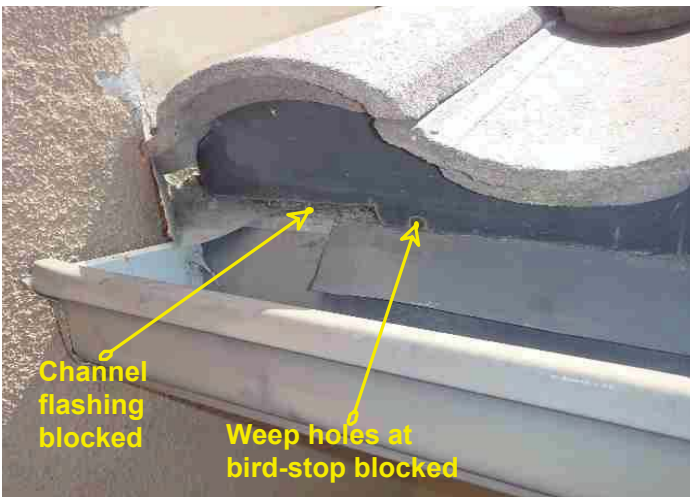
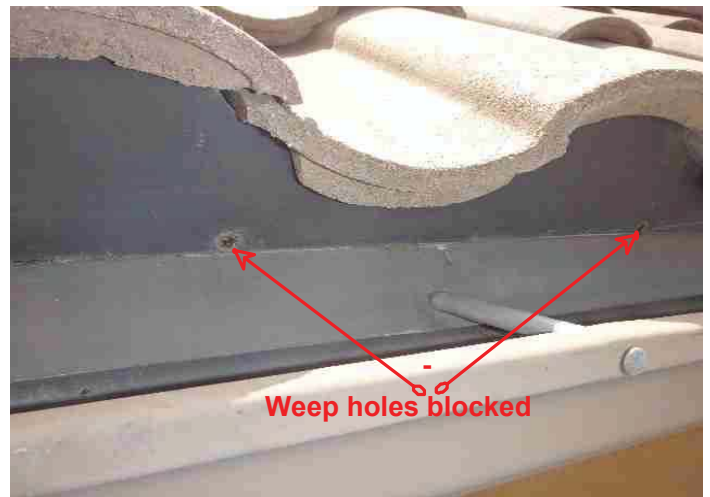
- ❖ Blocked drainage paths will cause water to back-up and may lead to leaking. The drainage paths and openings at bird-stop flashings, channel or pan flashings, and valley flashings need to be cleared of debris to allow drainage. Obstructed drainage paths may be contributing to water stains on the stucco (see above). Maintenance and cleaning is needed.

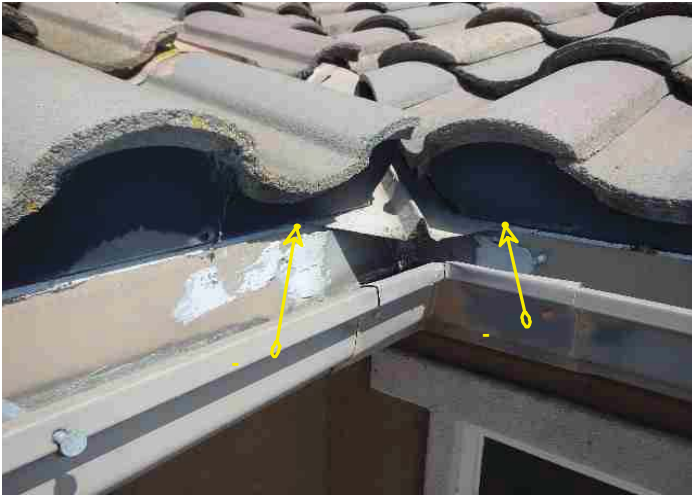
- The metal flashings at the roof valleys fall short of the roof's edges and therefore do not meet industry standards to properly dispense moisture from the roof system. Valley flashing is required to extend its entire width (normally 11" to either side of center) beyond the edges of the roof. Moisture damage at eaves may occur. While this practice was considered acceptable by some roofers in the past, it has never been endorsed by the roofing tile manufacturers. Seek the opinion of a qualified licensed roofing contractor and repair the valley flashings as needed.

Valley Flashings Short of edge - *Continued*

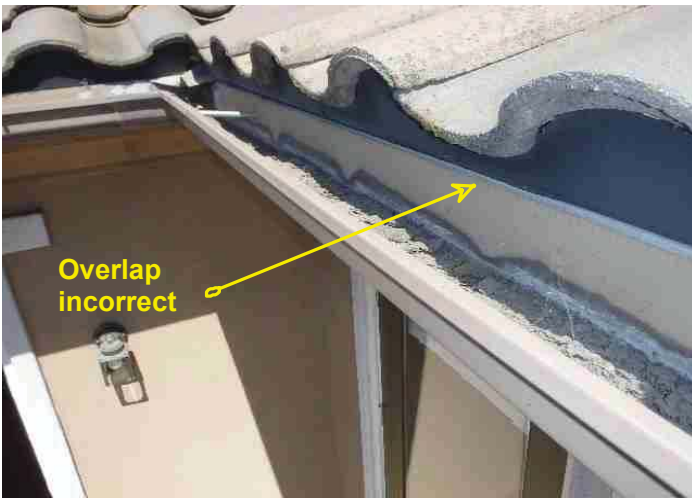
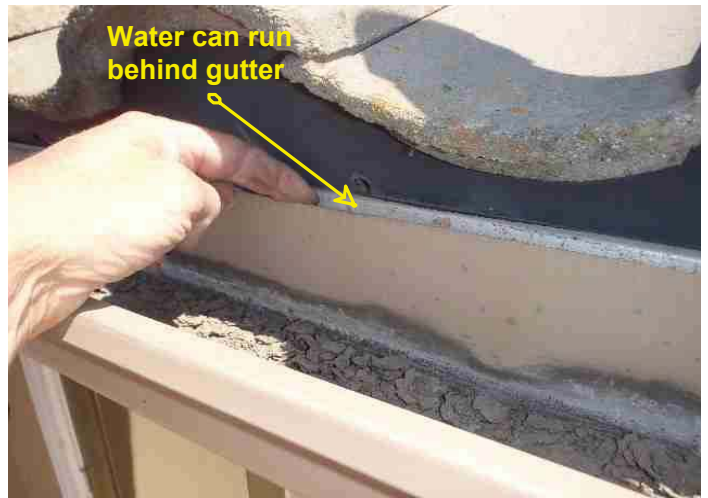
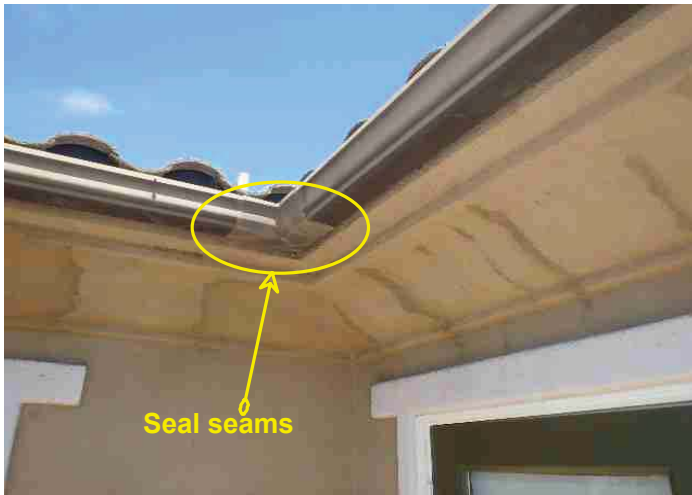
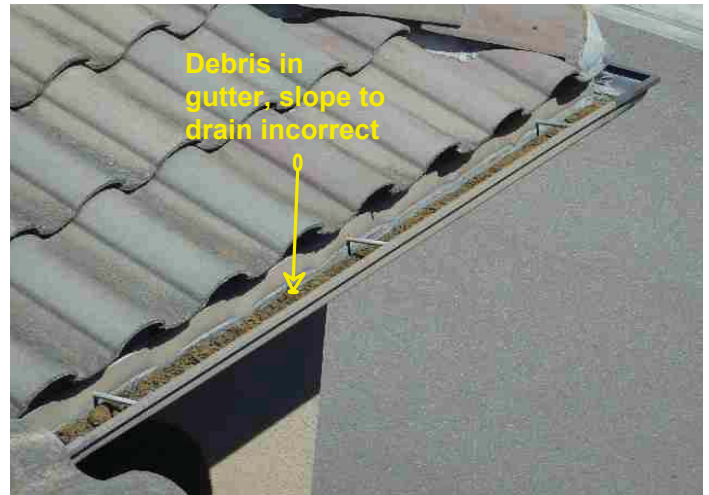
- ❖ The rain gutters need service; gutters are not installed under the drip edge metal in places, gutters do not slope completely towards the drains/down spouts at all portions, and debris was noted in some of the gutters. Deterioration of the rain gutters and wall cladding will be accelerated if water is allowed to remain in gutters. The rain gutters need to be serviced including cleaning, correcting installation at drip edge metal, correcting slope to drain, and sealing seams.

Service needed Lap under drip edge flashing Correct slope-to drain Clean and Seal seams - Continued

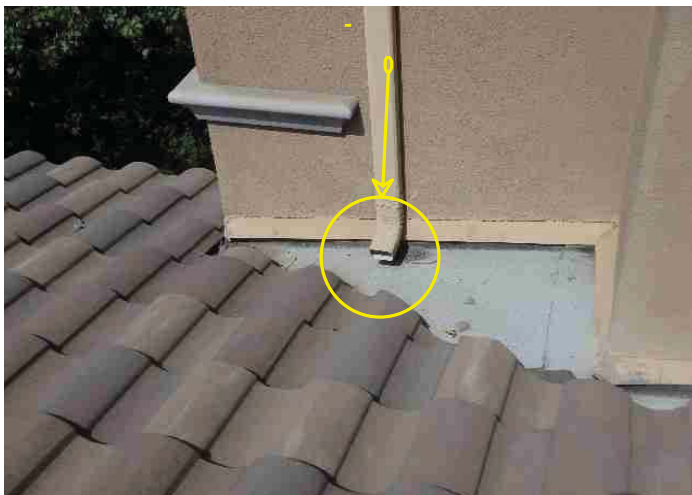
- The rain gutter system includes a design flaw wherein the water from a downspout is directed up into the roofing system instead of downward as needed. The design may be problematic. The rain gutter down spout should be routed down-slope along the drainage plane.

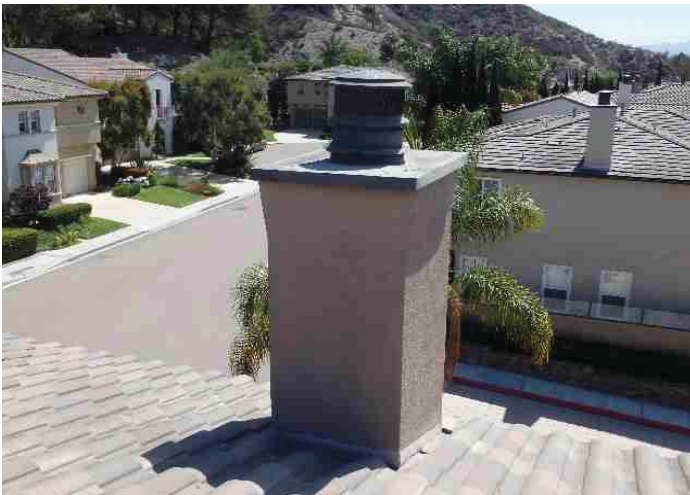
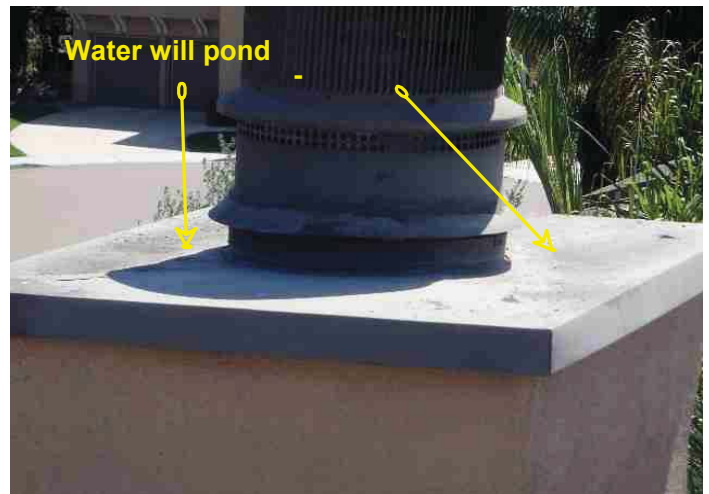
- ❖ The metal termination cover of the living room chimney flue chase is sunken and will hold or trap water. The cover should be repaired to shed water or replaced as necessary by a qualified licensed chimney contractor specializing in metal pre-fabricated fireplaces.

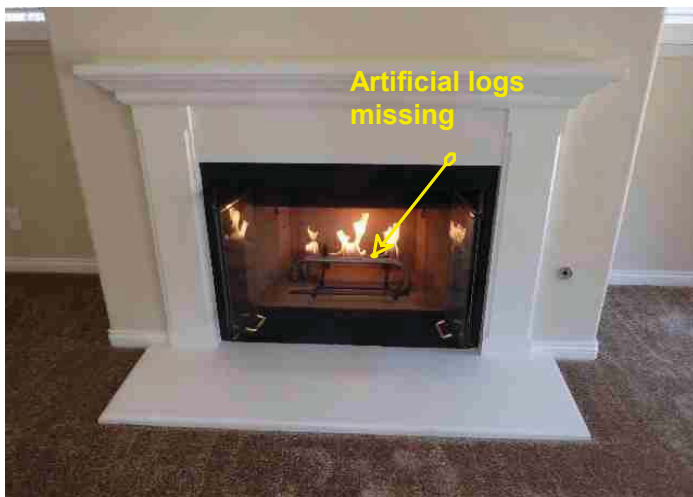
- ❖ The components (artificial logs) are missing and should be replaced by a qualified chimney specialist. Note;artificial logs are designed to be complete sets and installed in accordance with manufacturer's guidelines. Should the components be improperly placed/stacked or mis-matched with the firebox and burner, excessive carbon monoxide due to improper burning may occur.

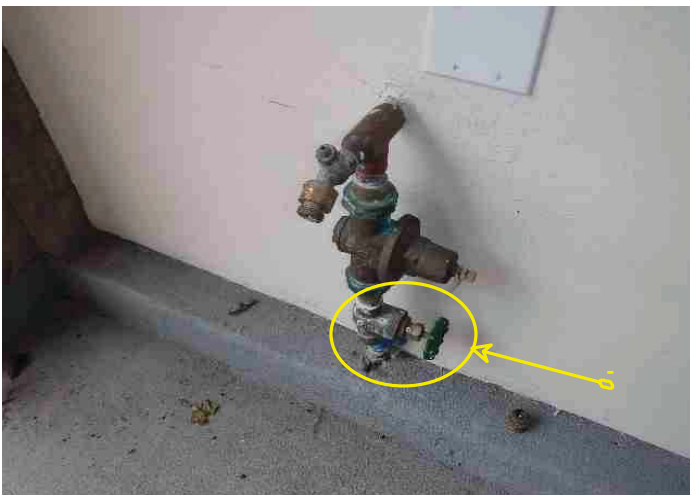
- The main water shut-off valve is a gate valve type. Gate valves are notorious for failing to open or close when needed, and often they will begin to leak when turned (we do not test or turn water shut-valves). As a preventative measure, have a qualified licensed plumber replace the main water shut-off valve with a more dependable ball valve.

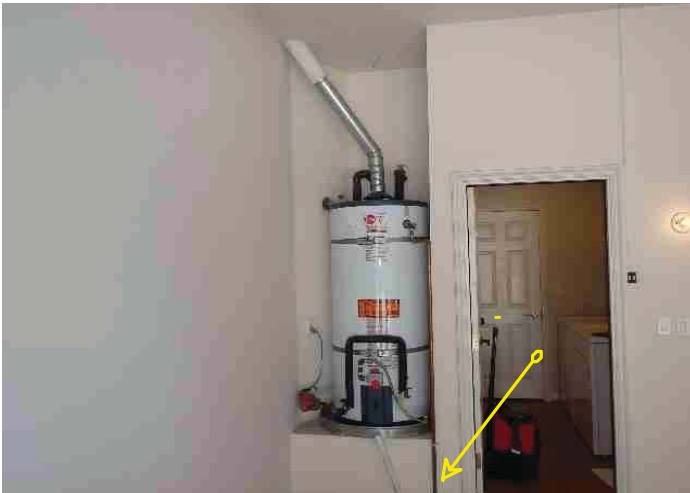
- ❖ The temperature pressure relief valve (TPRV) pipe termination is potentially unsafe as it is directed to the garage interior. The TPRV pipe's termination may have been allowed by the authority having jurisdiction but this was not determined. We advise routing the discharge pipe to the exterior and terminating it at a downward angle at a point between 24" and 6" above grade, per state building standards.

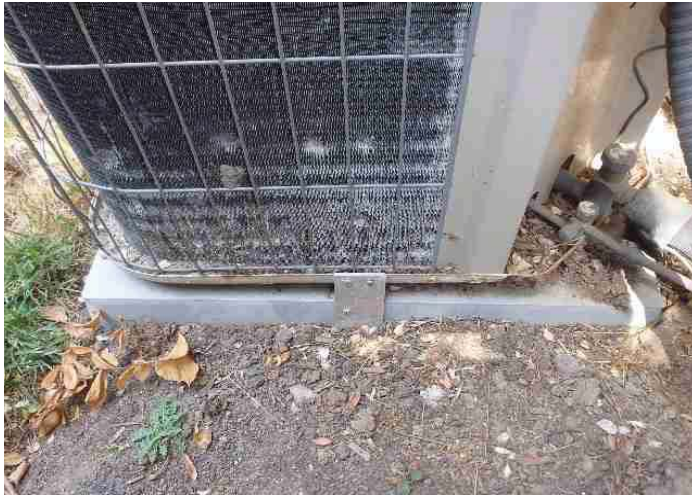
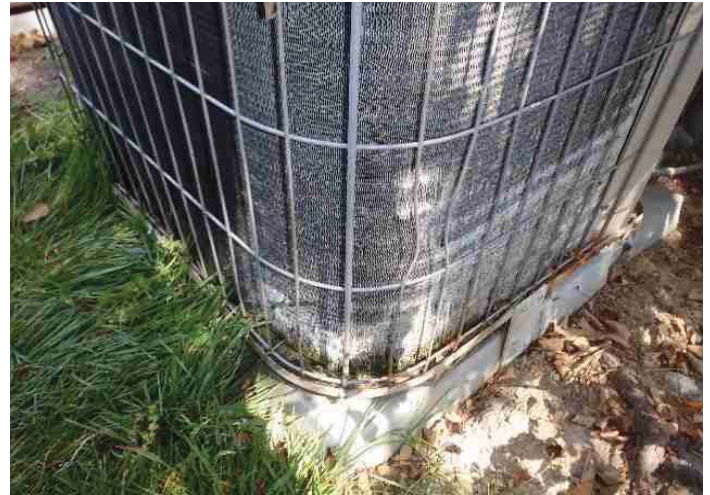
**Clean and service condensing coils - *Continued***

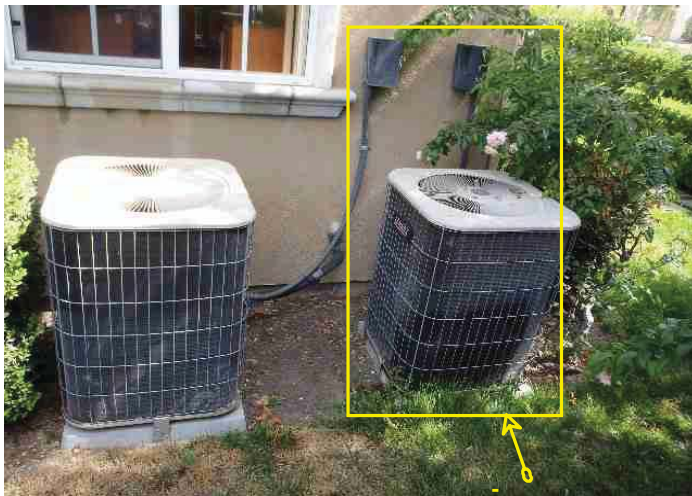
- ❖ The service disconnects and/or one condensing unit are unsafely positioned as access to the disconnects is blocked by the condensing coil. The service disconnects or condensing unit should be relocated to provide 30" wide work space for the safety of service personnel.

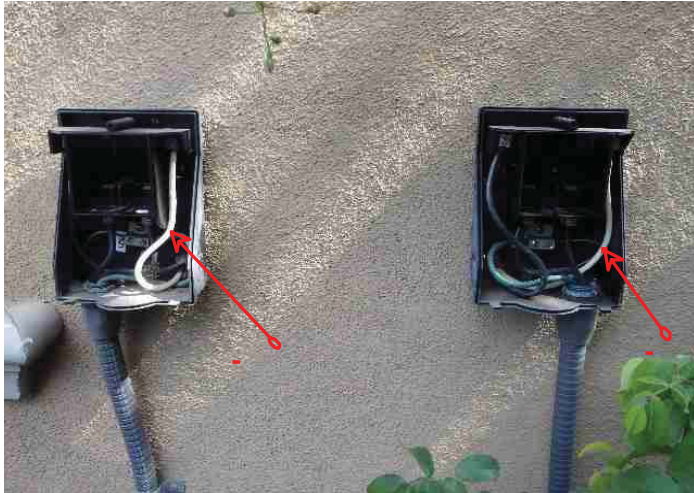
- ❖ The conductors (wires) in the electrical disconnects at the condensing coils are improperly identified; white colored wires are used as ungrounded (AKA "hot") conductors. Ungrounded conductors should be a continuous color other than white, gray or green. Black or red are the common insulation colors for ungrounded conductors. This mis-identification may be a safety hazard. A qualified licensed HVAC contractor or licensed electrician should correct as needed.

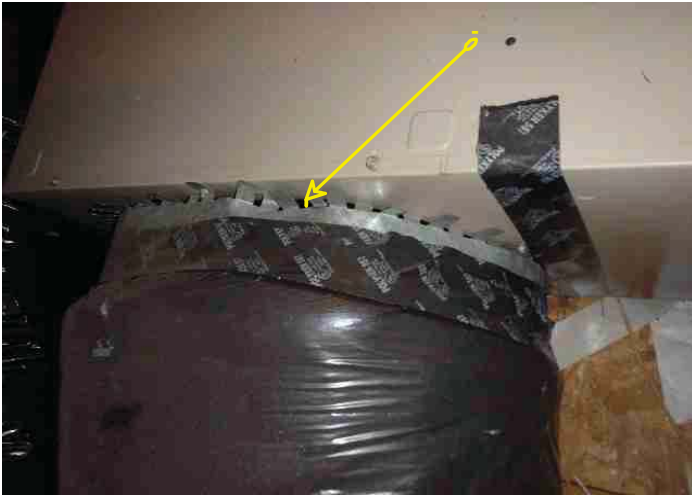
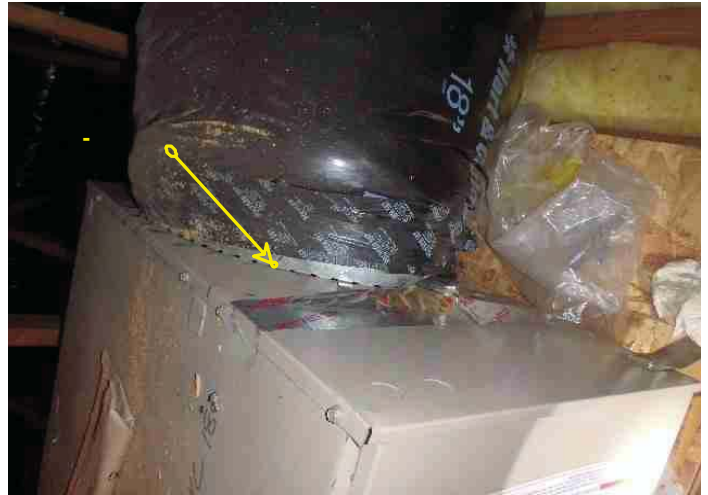
Ducts at returns need to be sealed Will draw in attic air - *Continued*

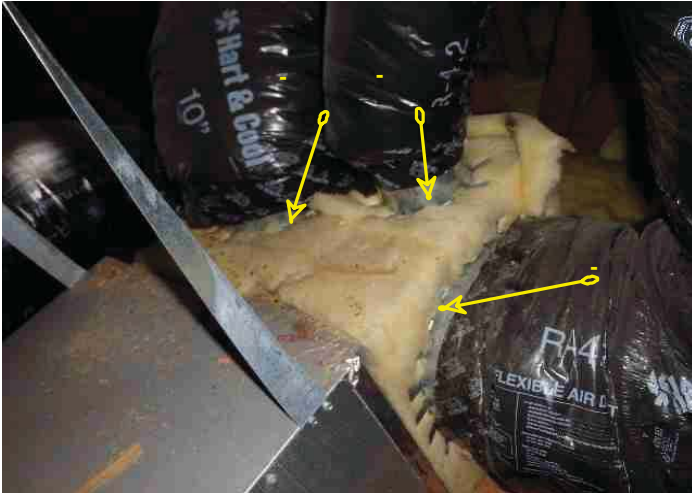
- The ducts are not adequately sealed at their seams at the evaporator coil/distribution plenum and loss of conditioned air was noted. A qualified HVAC contractor should seal the ducts and plenum as needed to save energy and increase system performance.

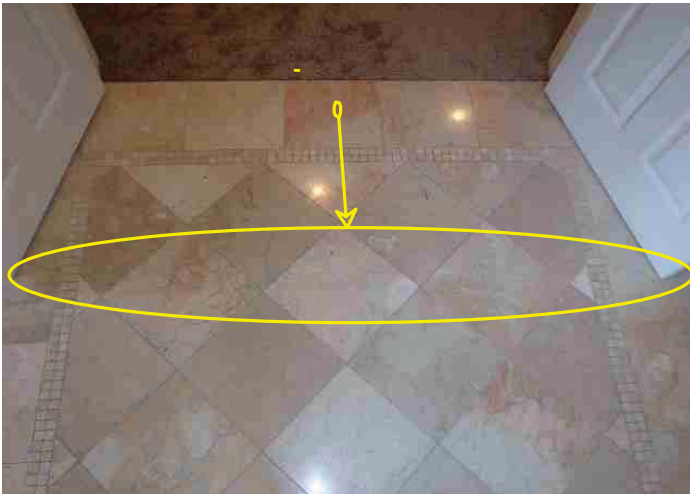
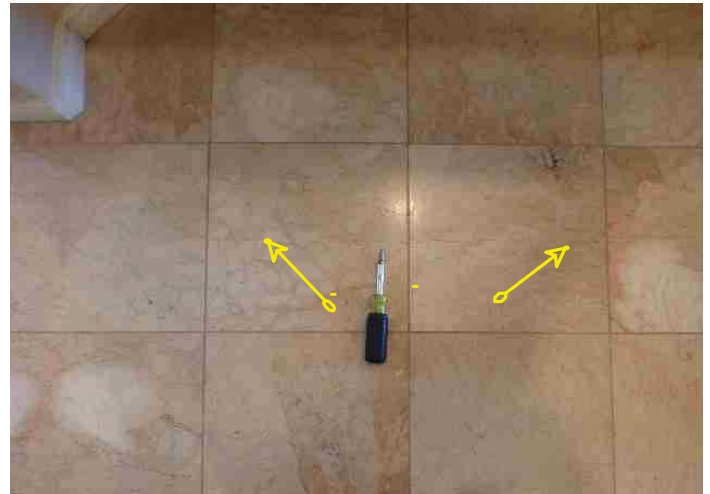
- ❖ Cracked tiles were noted at the entrance to the master bedroom and the vanity area in the master bathroom. This condition may be due to an insubstantial mortar base and/or to movement or deficiencies of the sub-floor beneath the tile. Replacement of the tile flooring is advised. Enlist a qualified licensed contractor for evaluation of the flooring and a cost estimate to replace it.

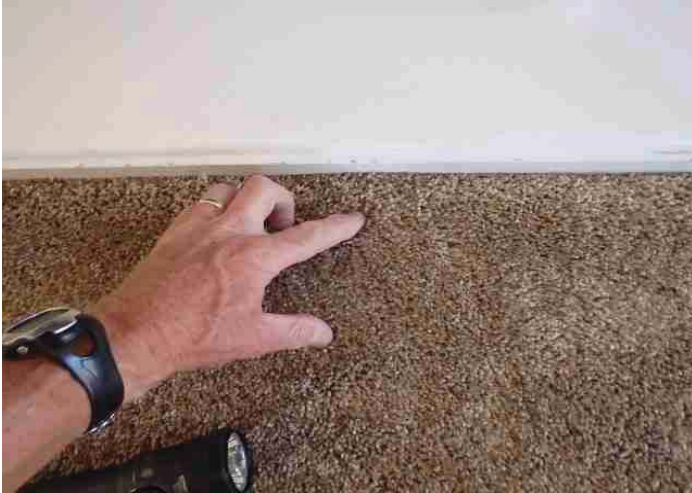
- ❖ There are carpet tack strips or other such prick hazards at the carpet floor near the master bedroom fireplace hearth extension (note, other tack strip or tack/nail hazards may be present and not found). Seek repair from a qualified flooring contractor.

Prick hazards Repair needed - *Continued*

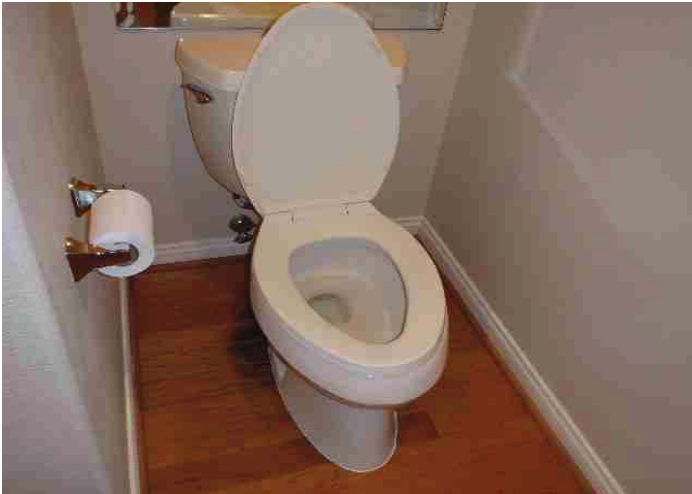
- ❖ Moisture damaged wood flooring was noted at the powder room (see "Bathrooms"). The floor was noted as damp as determined with a surface contact moisture meter. The flooring should be replaced as needed, and the leaking toilet corrected.

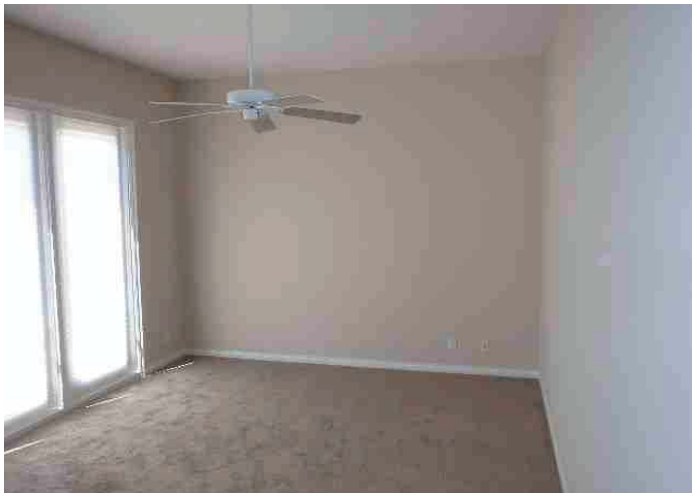
- ❖ A switched light source was not found and no switchable outlet for the downstairs extra room/den (wall switch controls ceiling fan, no luminaire). A switch activated light source at a habitable room's entry is a common sense safety feature, and correction is advised.

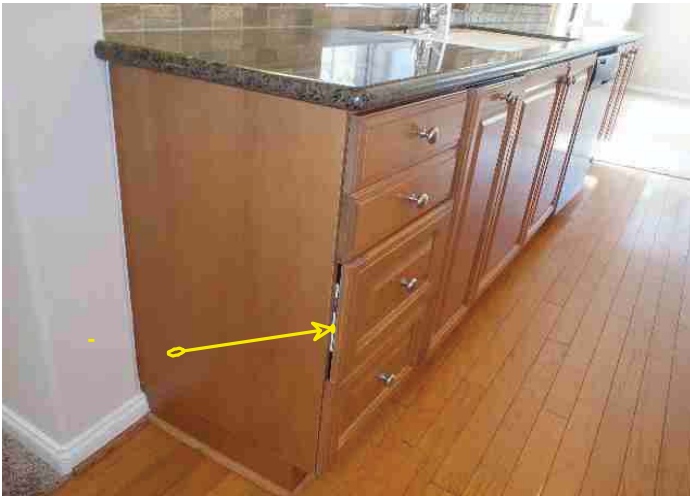
- ❖ A cabinet drawer does not close completely. The drawer should be serviced as needed.

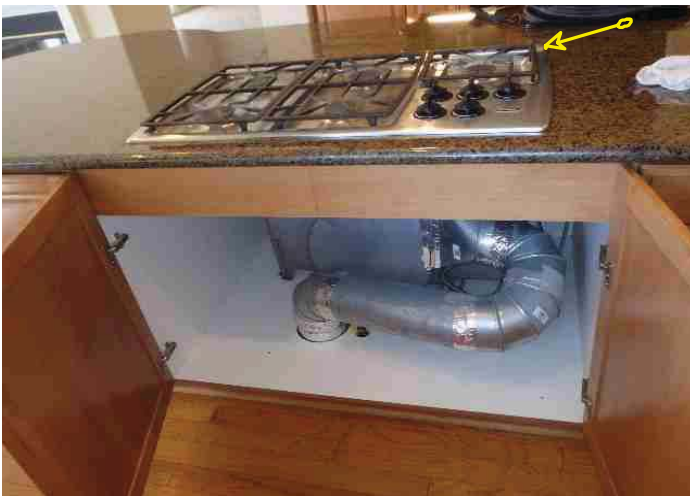
- ❖ The downdraft exhaust fan does not respond to the control switch, and should be repaired or replaced as needed.
