# Check It Out Property Inspections

## CONFIDENTIAL INSPECTION REPORT

2215 Papagayo Lane, San Diego, CA 92130

6/18/2014 10:00 am to 2:45 pm

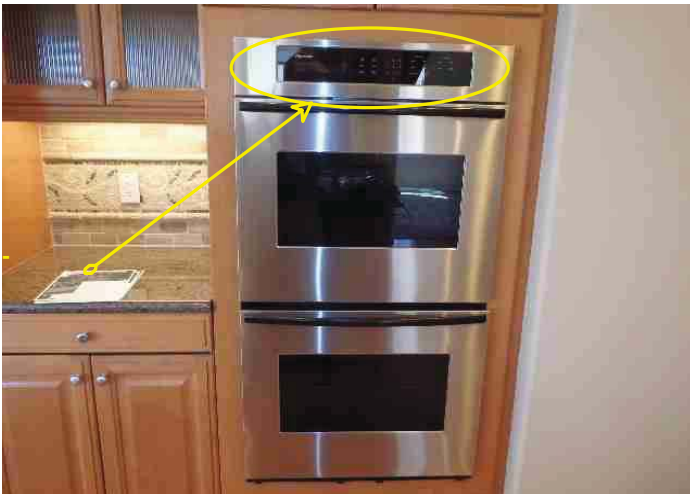
- ❖ The ovens' digital display (mode, temperature and/ or settings) was not functional - no numbers or symbols were visible or legible. The inspector was able to make the ovens respond in "Bake" mode but were unable to determine from the display if they were on, etc. "Broil" and other modes were not tested. Repair or replace the ovens display as needed.

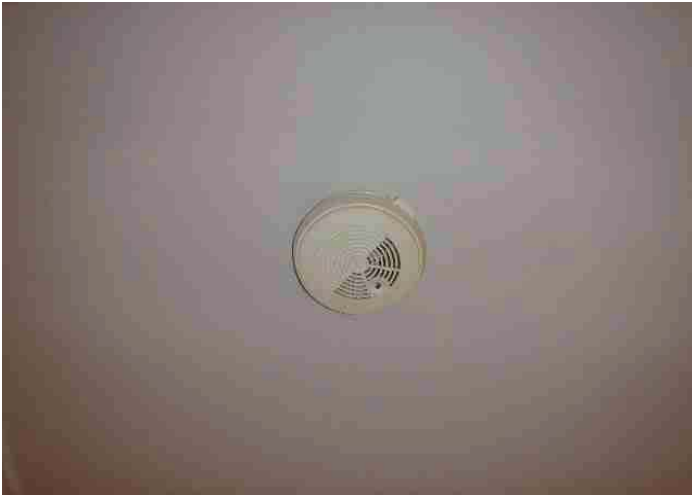
Old smoke alarms Replacement advised - *Continued*

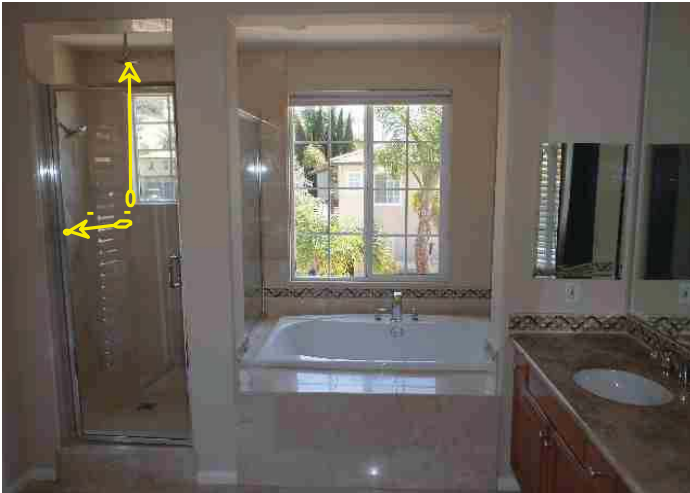
- ❖ The Hot and Cold water supplies are reversed at the overhead shower. This is a safety issue as accidental scalding may occur, and correction is needed.

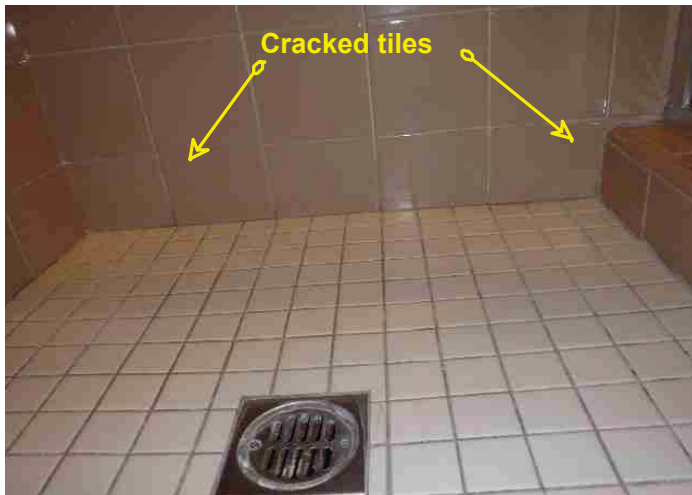
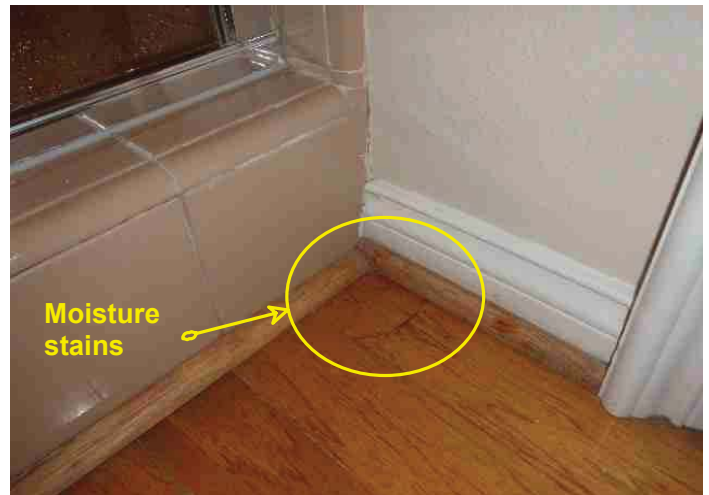
- ❖ The Hot and Cold water supplies are reversed; hot should be as valve turns to the left as indicated by manufacturer's colored markings. This is a safety issue as accidental scalding may occur, and correction is needed.
- ❖ There are cracked tiles in the shower, and there is moisture staining at the adjacent wall. The inspector does not endorse the integrity of the shower or any shower pan. Additionally, the cracked shower tiles may be a laceration hazard, and bacteria collection areas also. The shower should be re-tiled or renovated by a qualified licensed contractor.

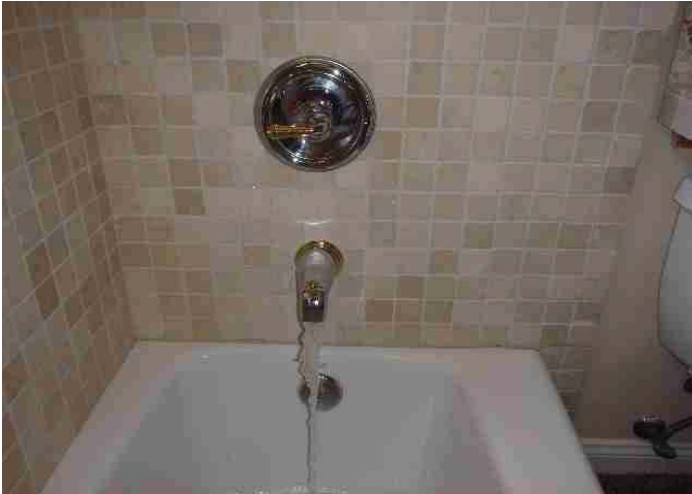
- ❖ Hot and Cold water is reversed at the tub/shower, which is a safety hazard. Accidental scalding may occur, and correction by a qualified plumbing contractor is needed.

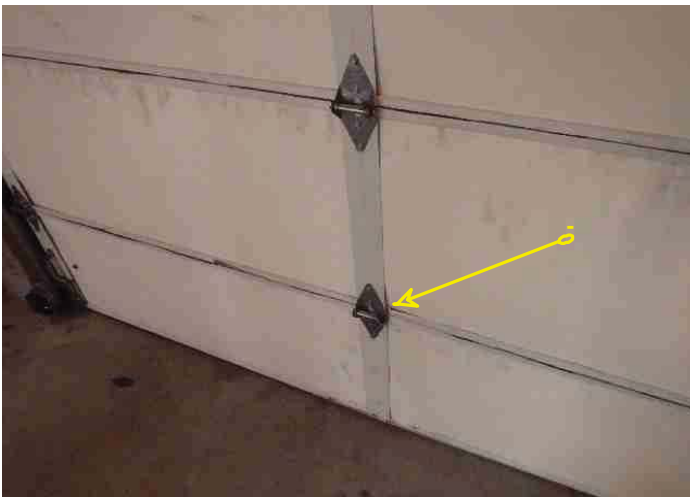
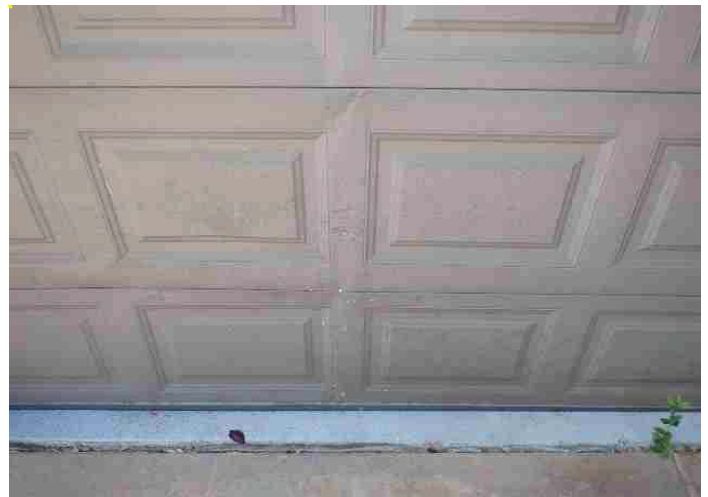
- ❑ The west garage door has metal panels with dents and damage. The damage did not appear to effect the operation of the door at the time of the inspection and it would not necessarily need to be repaired at this time, however, the panels will prone to flexing and cracking. Consider enlisting a qualified garage door contractor for evaluation, and replace or repair the panels if advised.
